# **Tree Report**

# **8 Hobart Avenue**

# **Forrest**

## 8 Hobart Avenue, Forrest: Tree Report

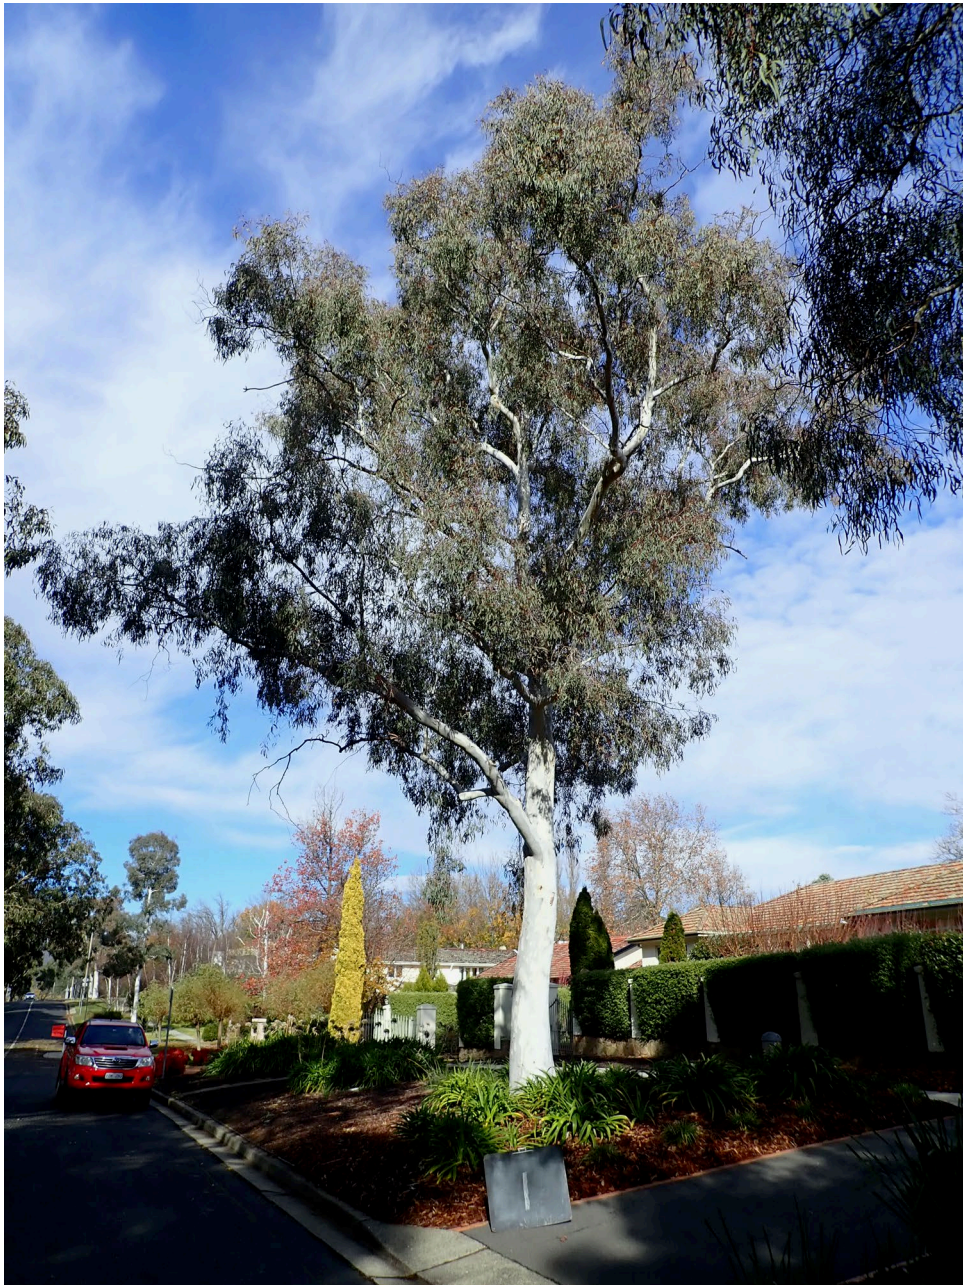
### Tree number 1:

It is a *Eucalyptus mannifera* of the following dimensions:-

Height:	15.5m
Circumference at 1m:	1800mm
Canopy:	13m

The tree is healthy and free of major defects. It will be protected during the proposed works.

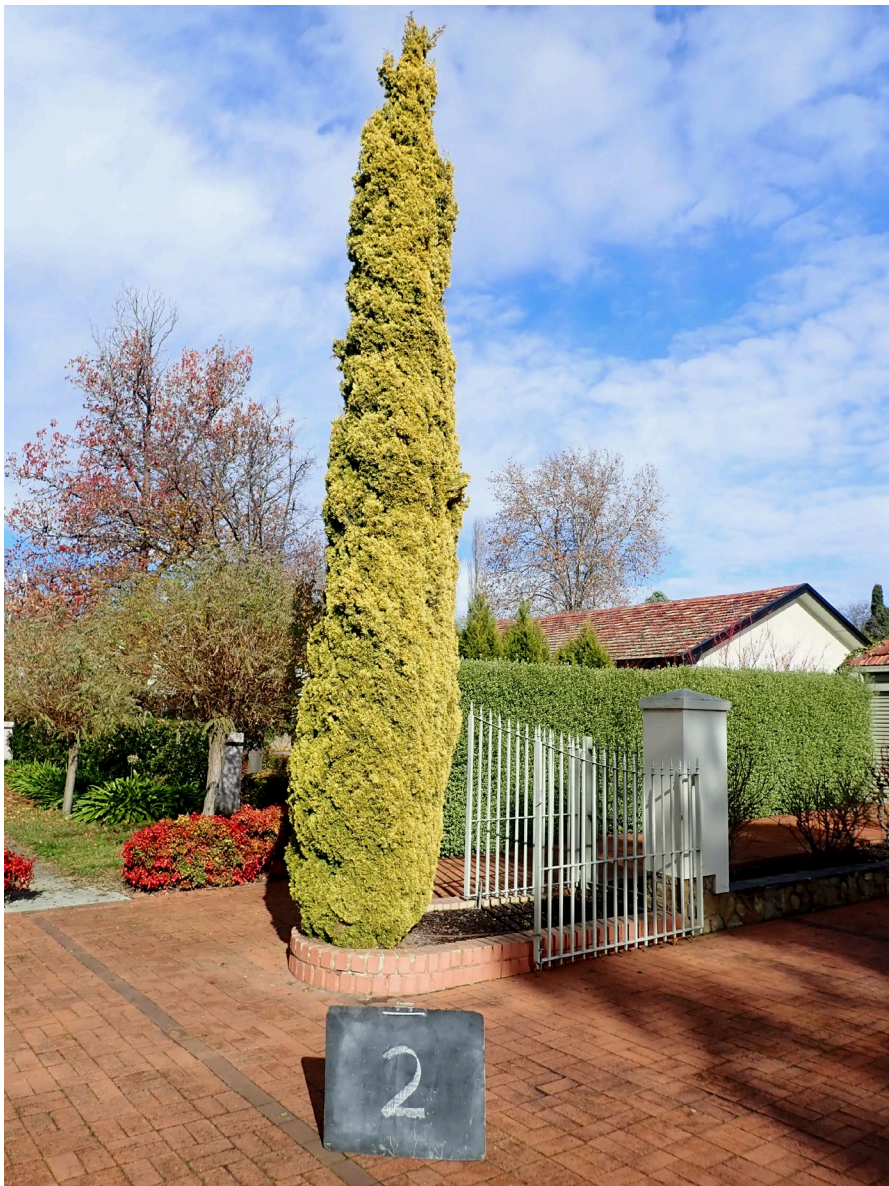
**Tree number 2:**

Is a *Cupressus sempervirens* var. Swains Golden (Roman cypress) of the following dimensions:-

Height:	7.5m
Circumference at 1m:	800mm
Canopy:	1m

This tree is far smaller than the ACT dimensions for a regulated tree of 12m in height and as such would be able to be removed under that authority. It is healthy but is inappropriately positioned at the very front of the block and contained within a brick kerb.. It has significant potential to damage pavement infrastructure as its roots develop. The tree offers very little aesthetically to the streetscape which is dominated by large native species. It is recommended that it be removed to allow for the redevelopment of the block.

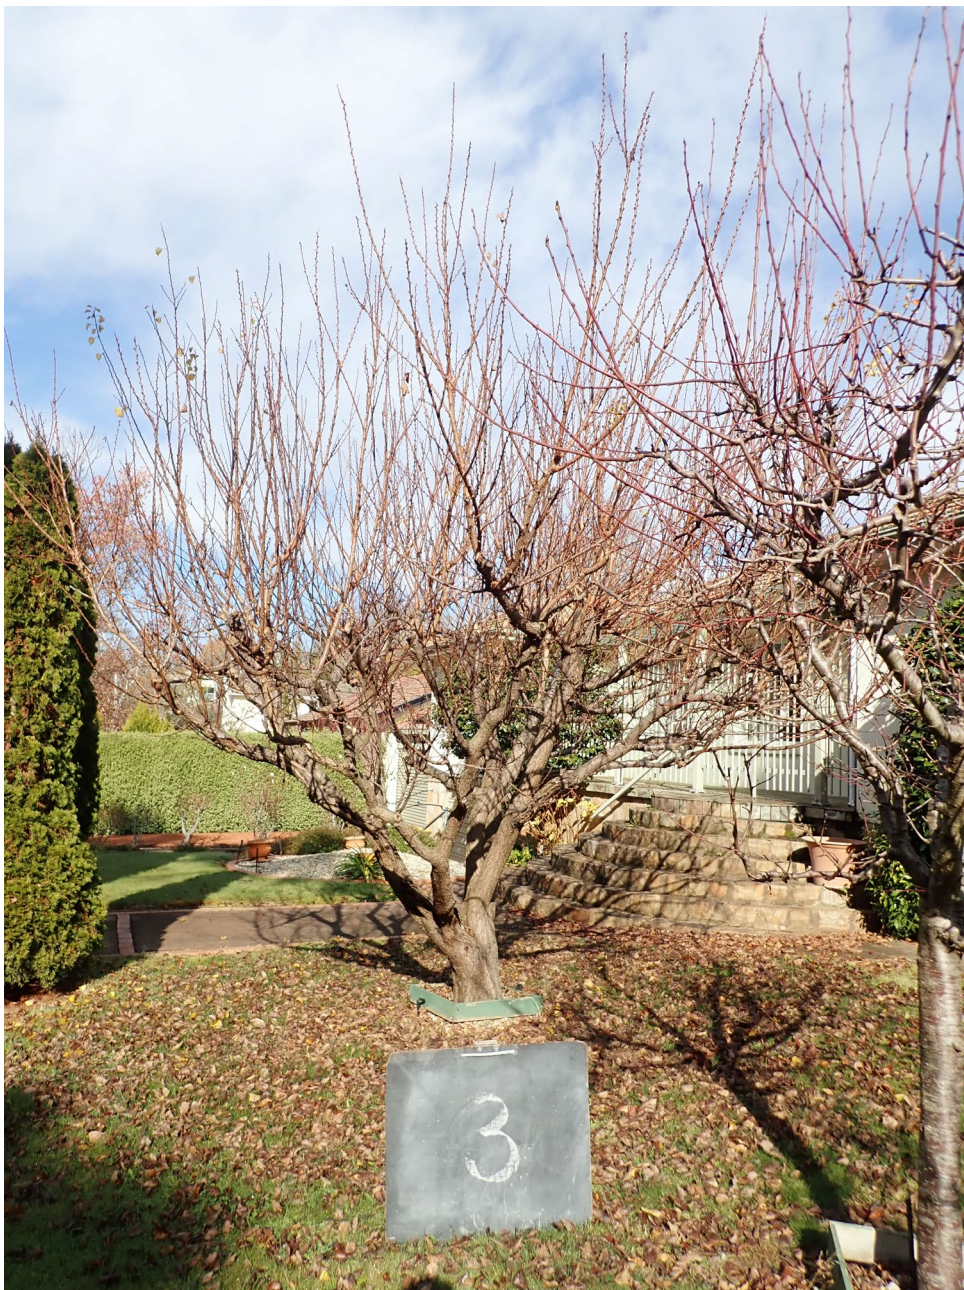
**Tree number 3:**

is a *Prunus* sp. (Flowering cherry). The exact species cannot be identified at this time of the year.

Height:	4.5m
Circumference at 1m:	1200mm
Canopy:	6m

It has rot in several of the stems and is in early stages of senility. It should be removed as part of the redevelopment of the landscape.

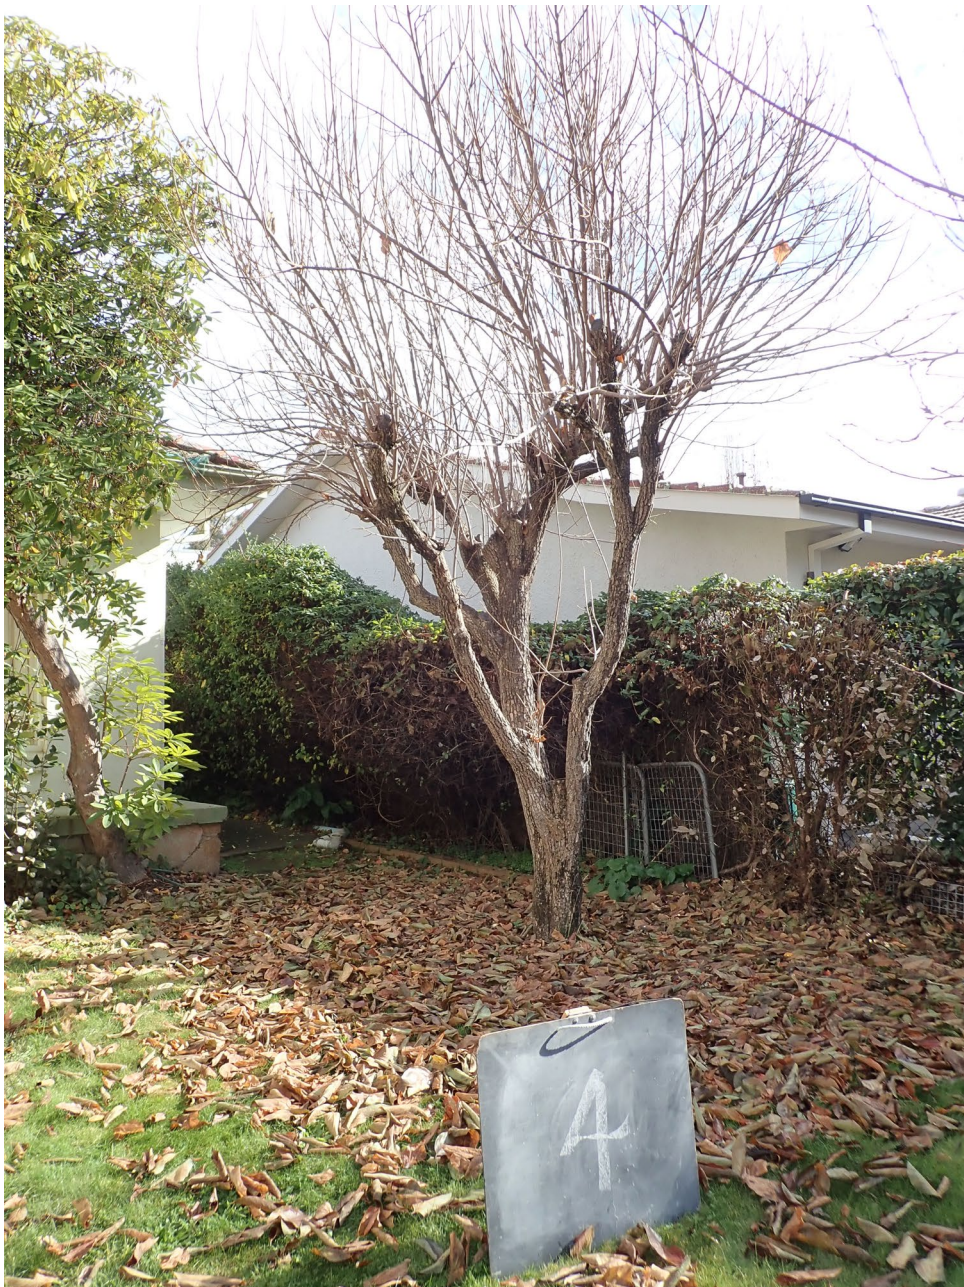
**Tree number 4:**

Is a *Diospyros kaki* (Persimmon) of the following dimensions:-

Height:	6m
Circumference at 1m:	800mm
Canopy:	5m

This fruit tree is of no significance as part of the suburb tree canopy and should be removed to allow for a revived garden.

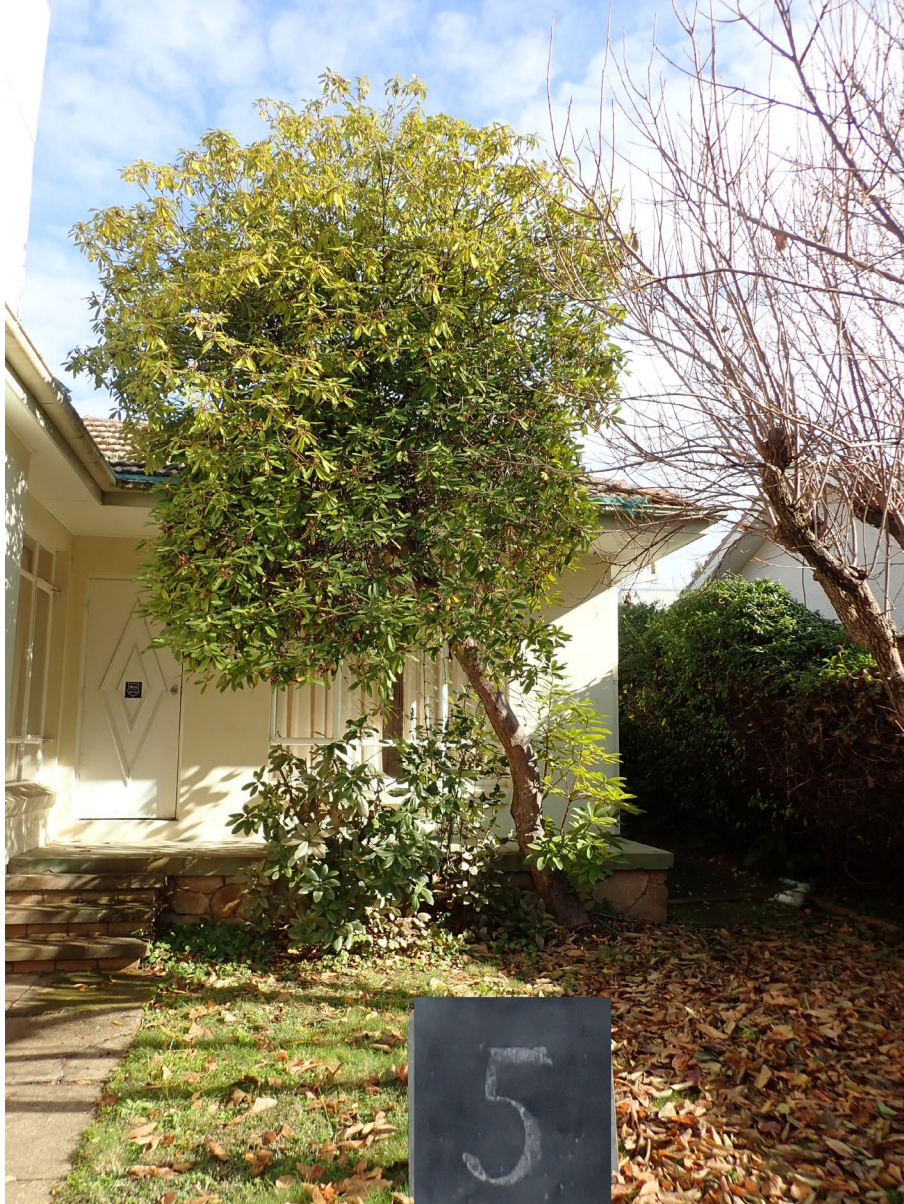
The plant identified as tree 5 is a *Rhododendron* sp. it is not classified as a tree notwithstanding its tree like form in this specimen. It should be removed.
