Raising London Circuit

Environmental Assessment –
Contamination

29th September 2021

Project No.: 0527116

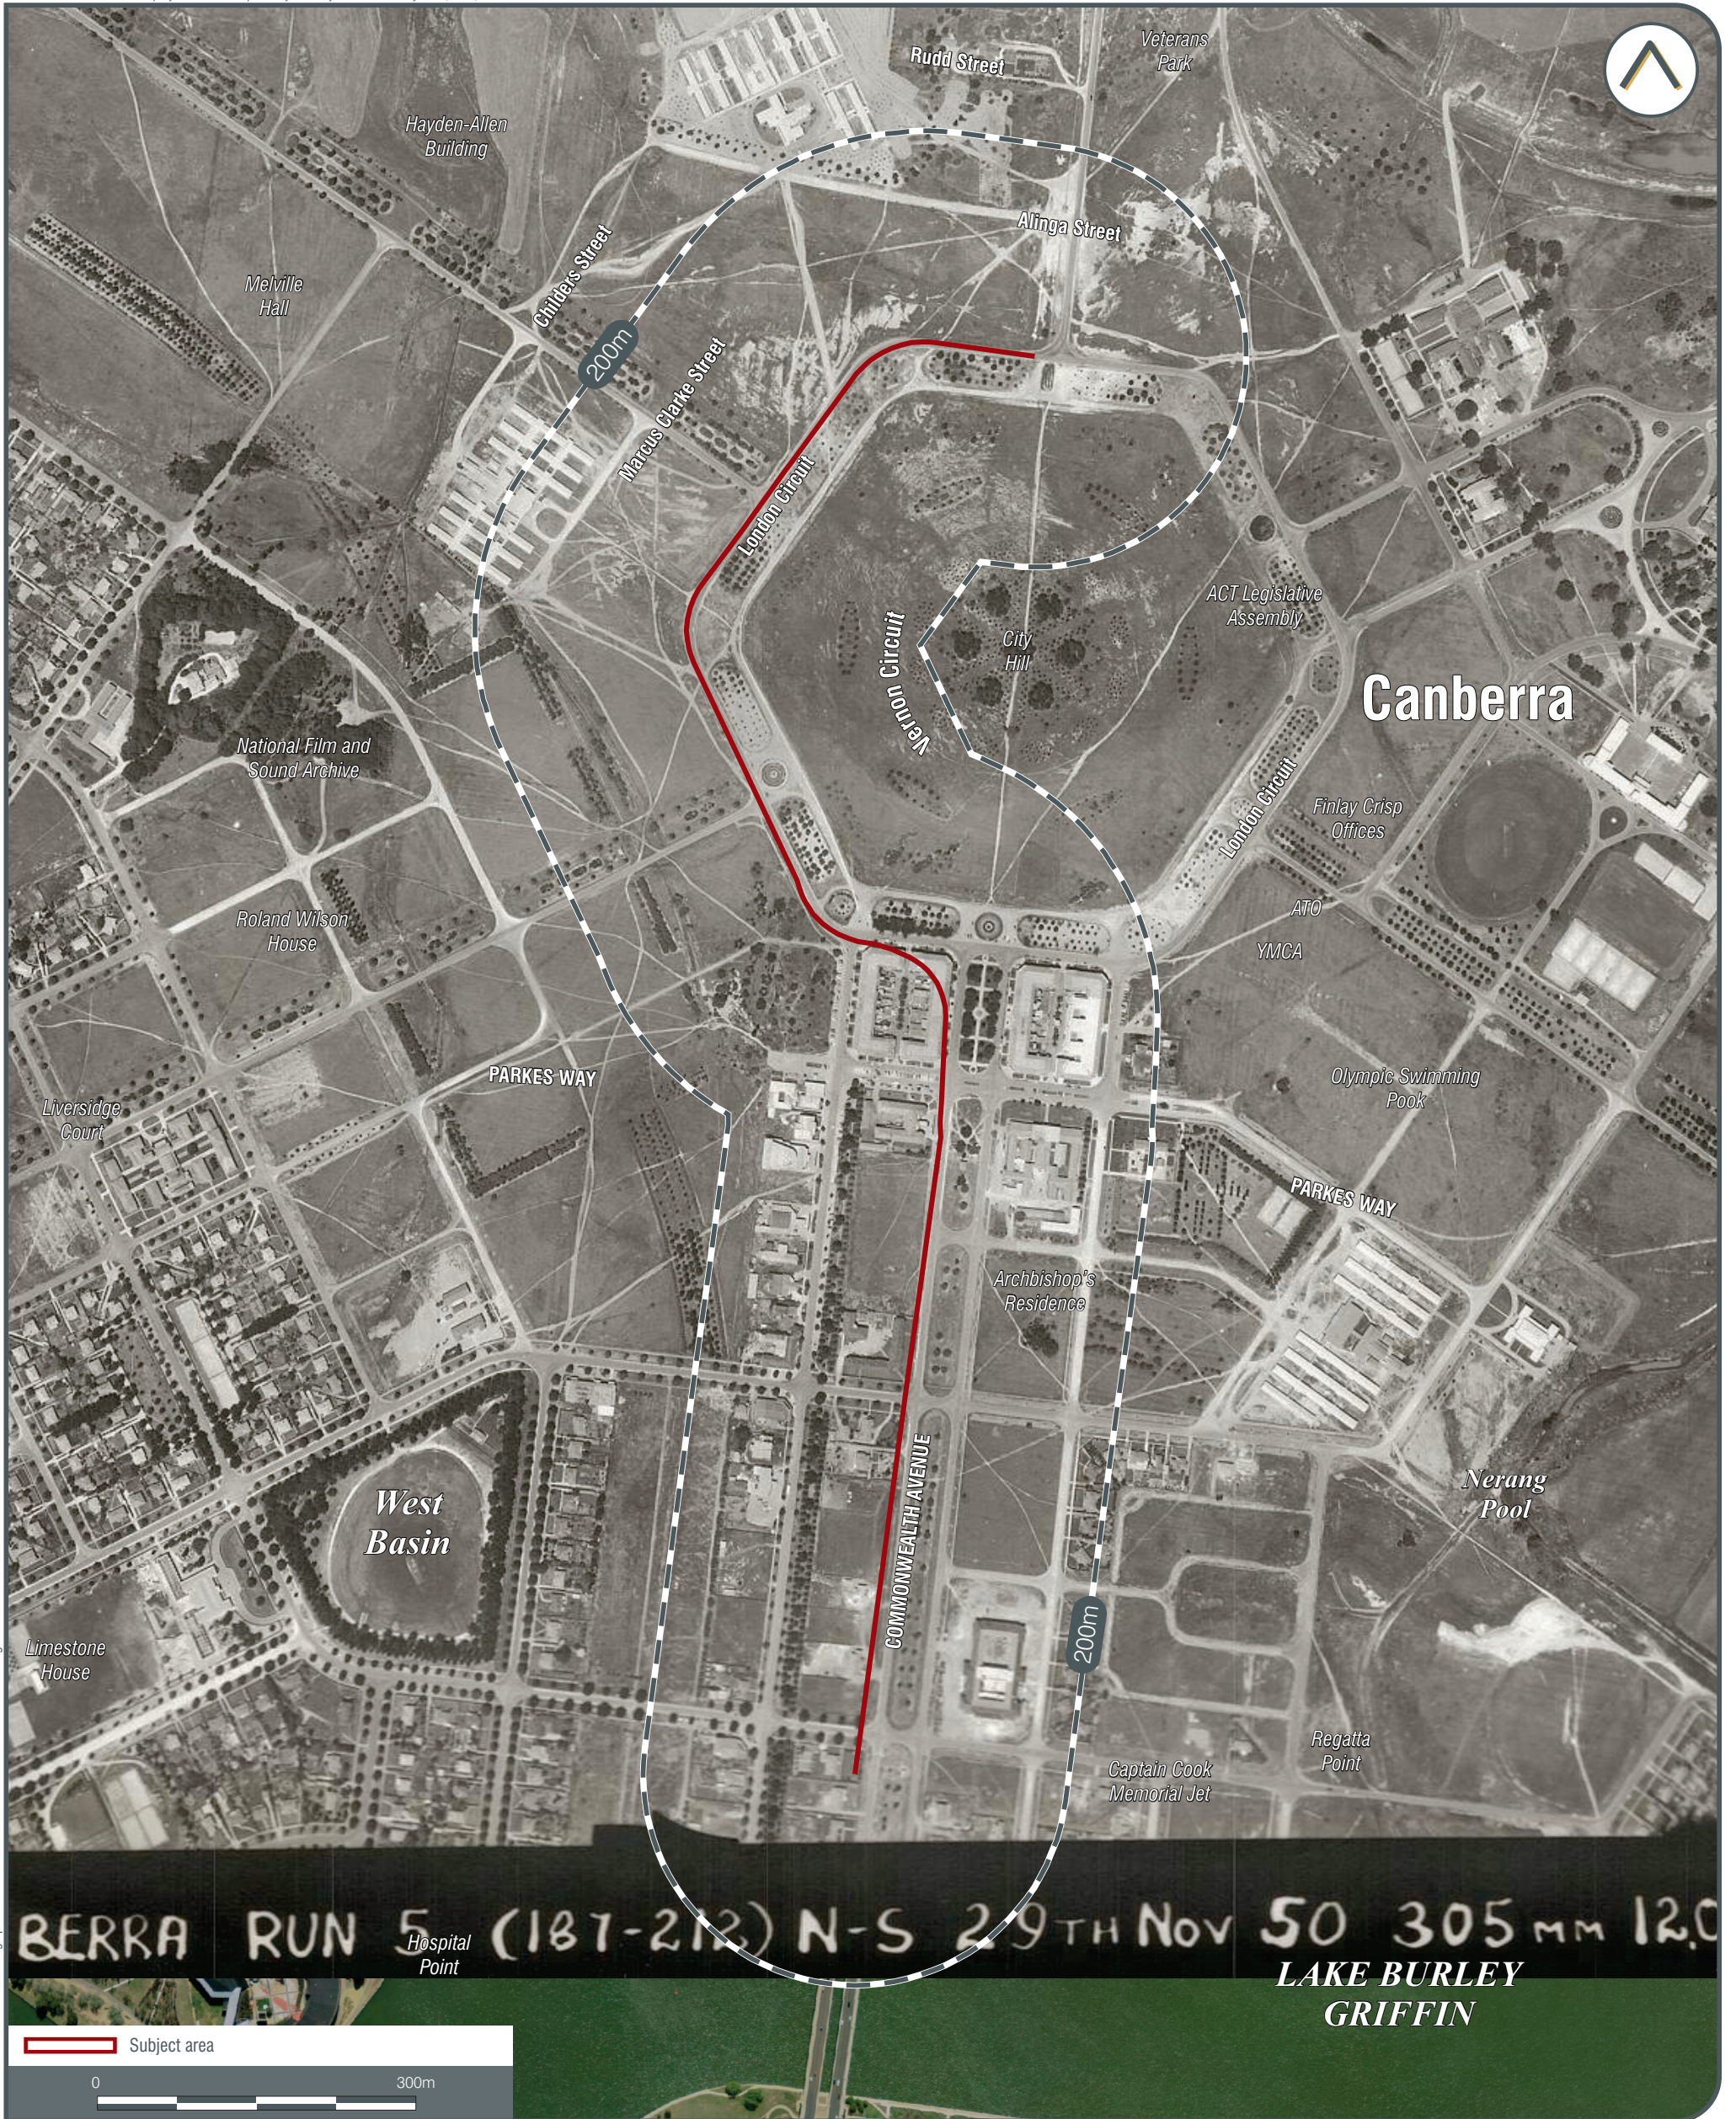
HISTORICAL AERIAL PHOTOGRAPH - 1951

Year	Description
1951 – Black and White	<ul style="list-style-type: none"> ■ Site Area: London Circuit is present within its current alignment. Two commercial / office buildings are present on the southern boundary of London Circuit at the commencement of Commonwealth Avenue within the current south eastern and south western “clover leaf” portions of the Site. Commonwealth Avenue is present in its current alignment with ornamental garden beds located within the centre of the road. ■ Surrounding Area: The surrounding area is comprised of undeveloped / cleared land with several unsealed tracks and scattered vegetation. Roadways within the surrounding area indicate the surrounding area has been subdivided for future development to occur. Unsealed roads in the current alignment of University Avenue located approximately 100m to the north west of the RLC site extend northwest from London Circuit. Low density residential buildings are located to the west and southwest of Commonwealth Avenue and several commercial buildings are located to the east. A military barracks is located to the east of the site within the vicinity of Parkes Way.

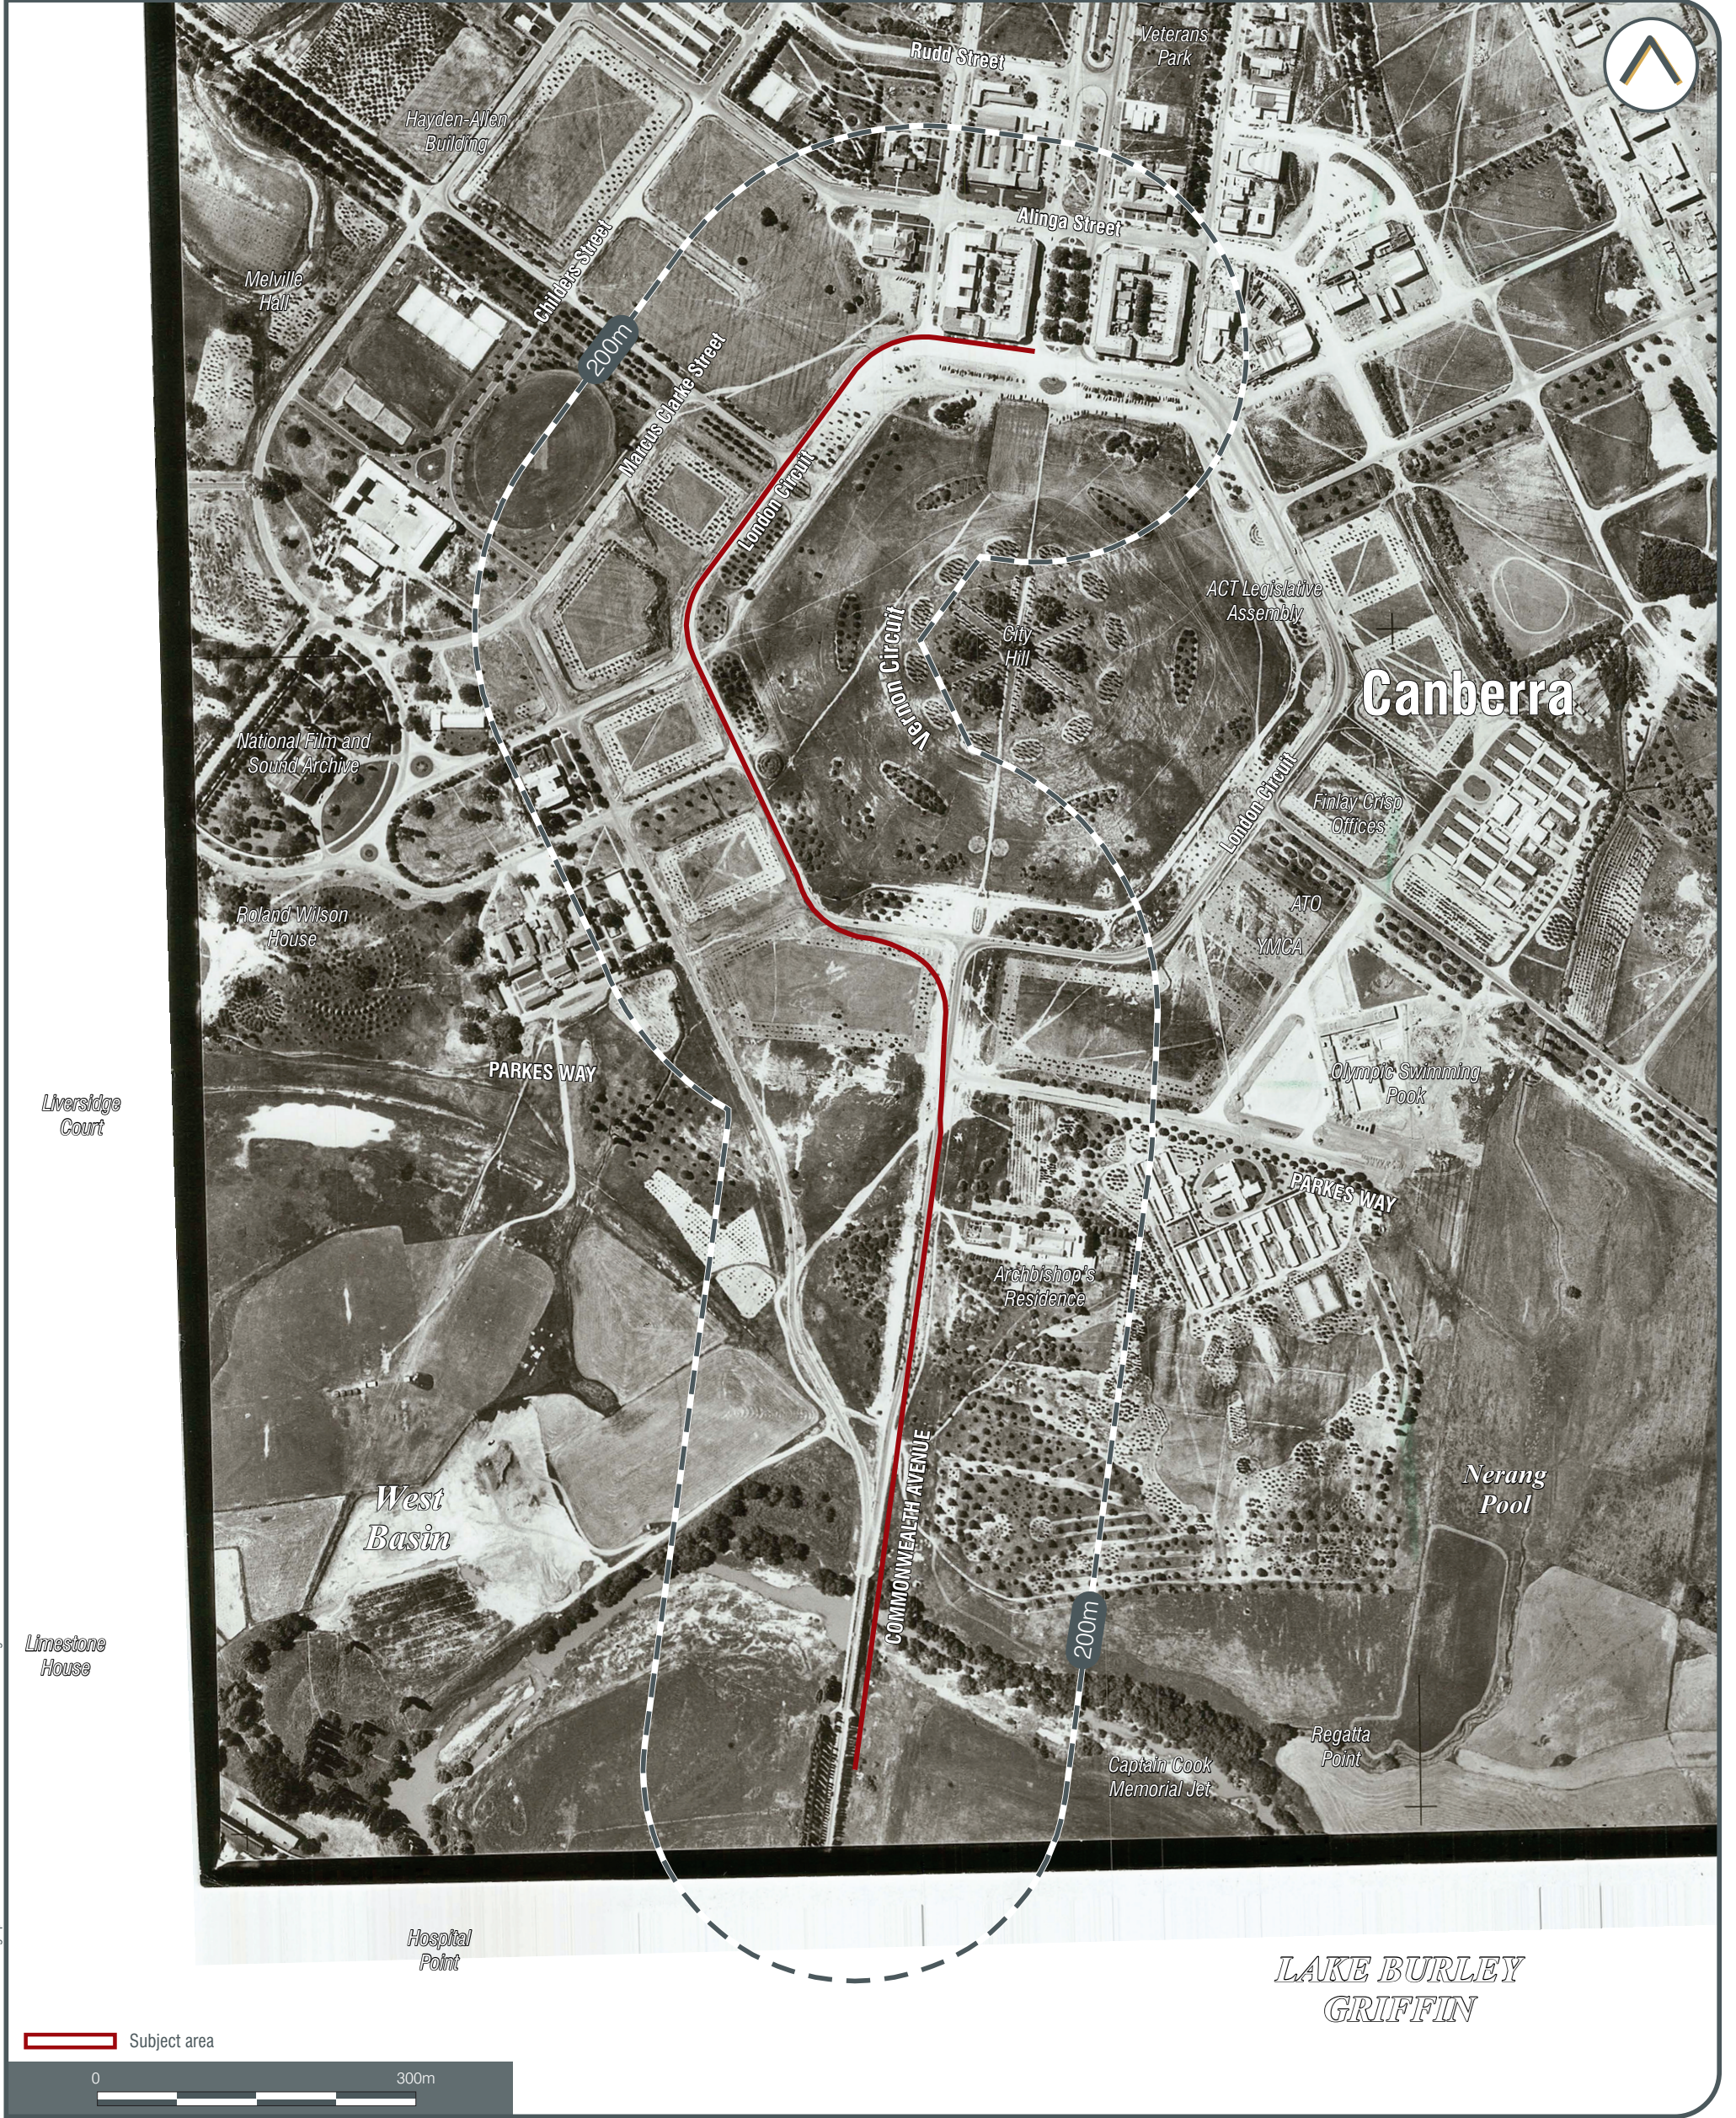
HISTORICAL AERIAL PHOTOGRAPH - 1955

1955 – Black and White	<ul style="list-style-type: none"> ■ Site Area: The northern portion of London Circuit appears to have been cleared. An unsealed road intersects the Site in the northern portion of Commonwealth Avenue. A bridge has been constructed on Commonwealth Avenue at the southernmost extent of the Site. ■ Surrounding Area: The majority of buildings on either side of Commonwealth Avenue have been demolished with the exception of the Archbishop’s Residence which comprises a large rectangular shaped building. The construction of Parkes Way appears to have commenced to the east of Commonwealth Avenue. Commercial development is observed to the north east and west of London Circuit. Unsealed roads along the current alignments of Gordon Street and Edinburgh Avenue have been constructed. Additional roadways have also been developed to the northeast of the site.
1961 – Black and White	<ul style="list-style-type: none"> ■ Site Area: The Site appears generally consistent with previous aerial photography with the exception of the construction of an unsealed road bisecting Commonwealth Avenue in the current alignment of Parkes Way. ■ Surrounding Area: Canberra Hospital is visible to the south west of the Site. Roadways in the current alignment of Vernon Circle and Northbourne Avenue have been constructed with Commonwealth Avenue extended to the north to join Vernon Circle. Commercial development has occurred in a small portion southwest of the site. The remaining surrounding area is still generally comprised of commercial development to the north, northeast and northwest as well as vacant/cleared land to the south of the site. Land clearing / construction works appear to be occurring under the bridge in the southern portion of Commonwealth Avenue.

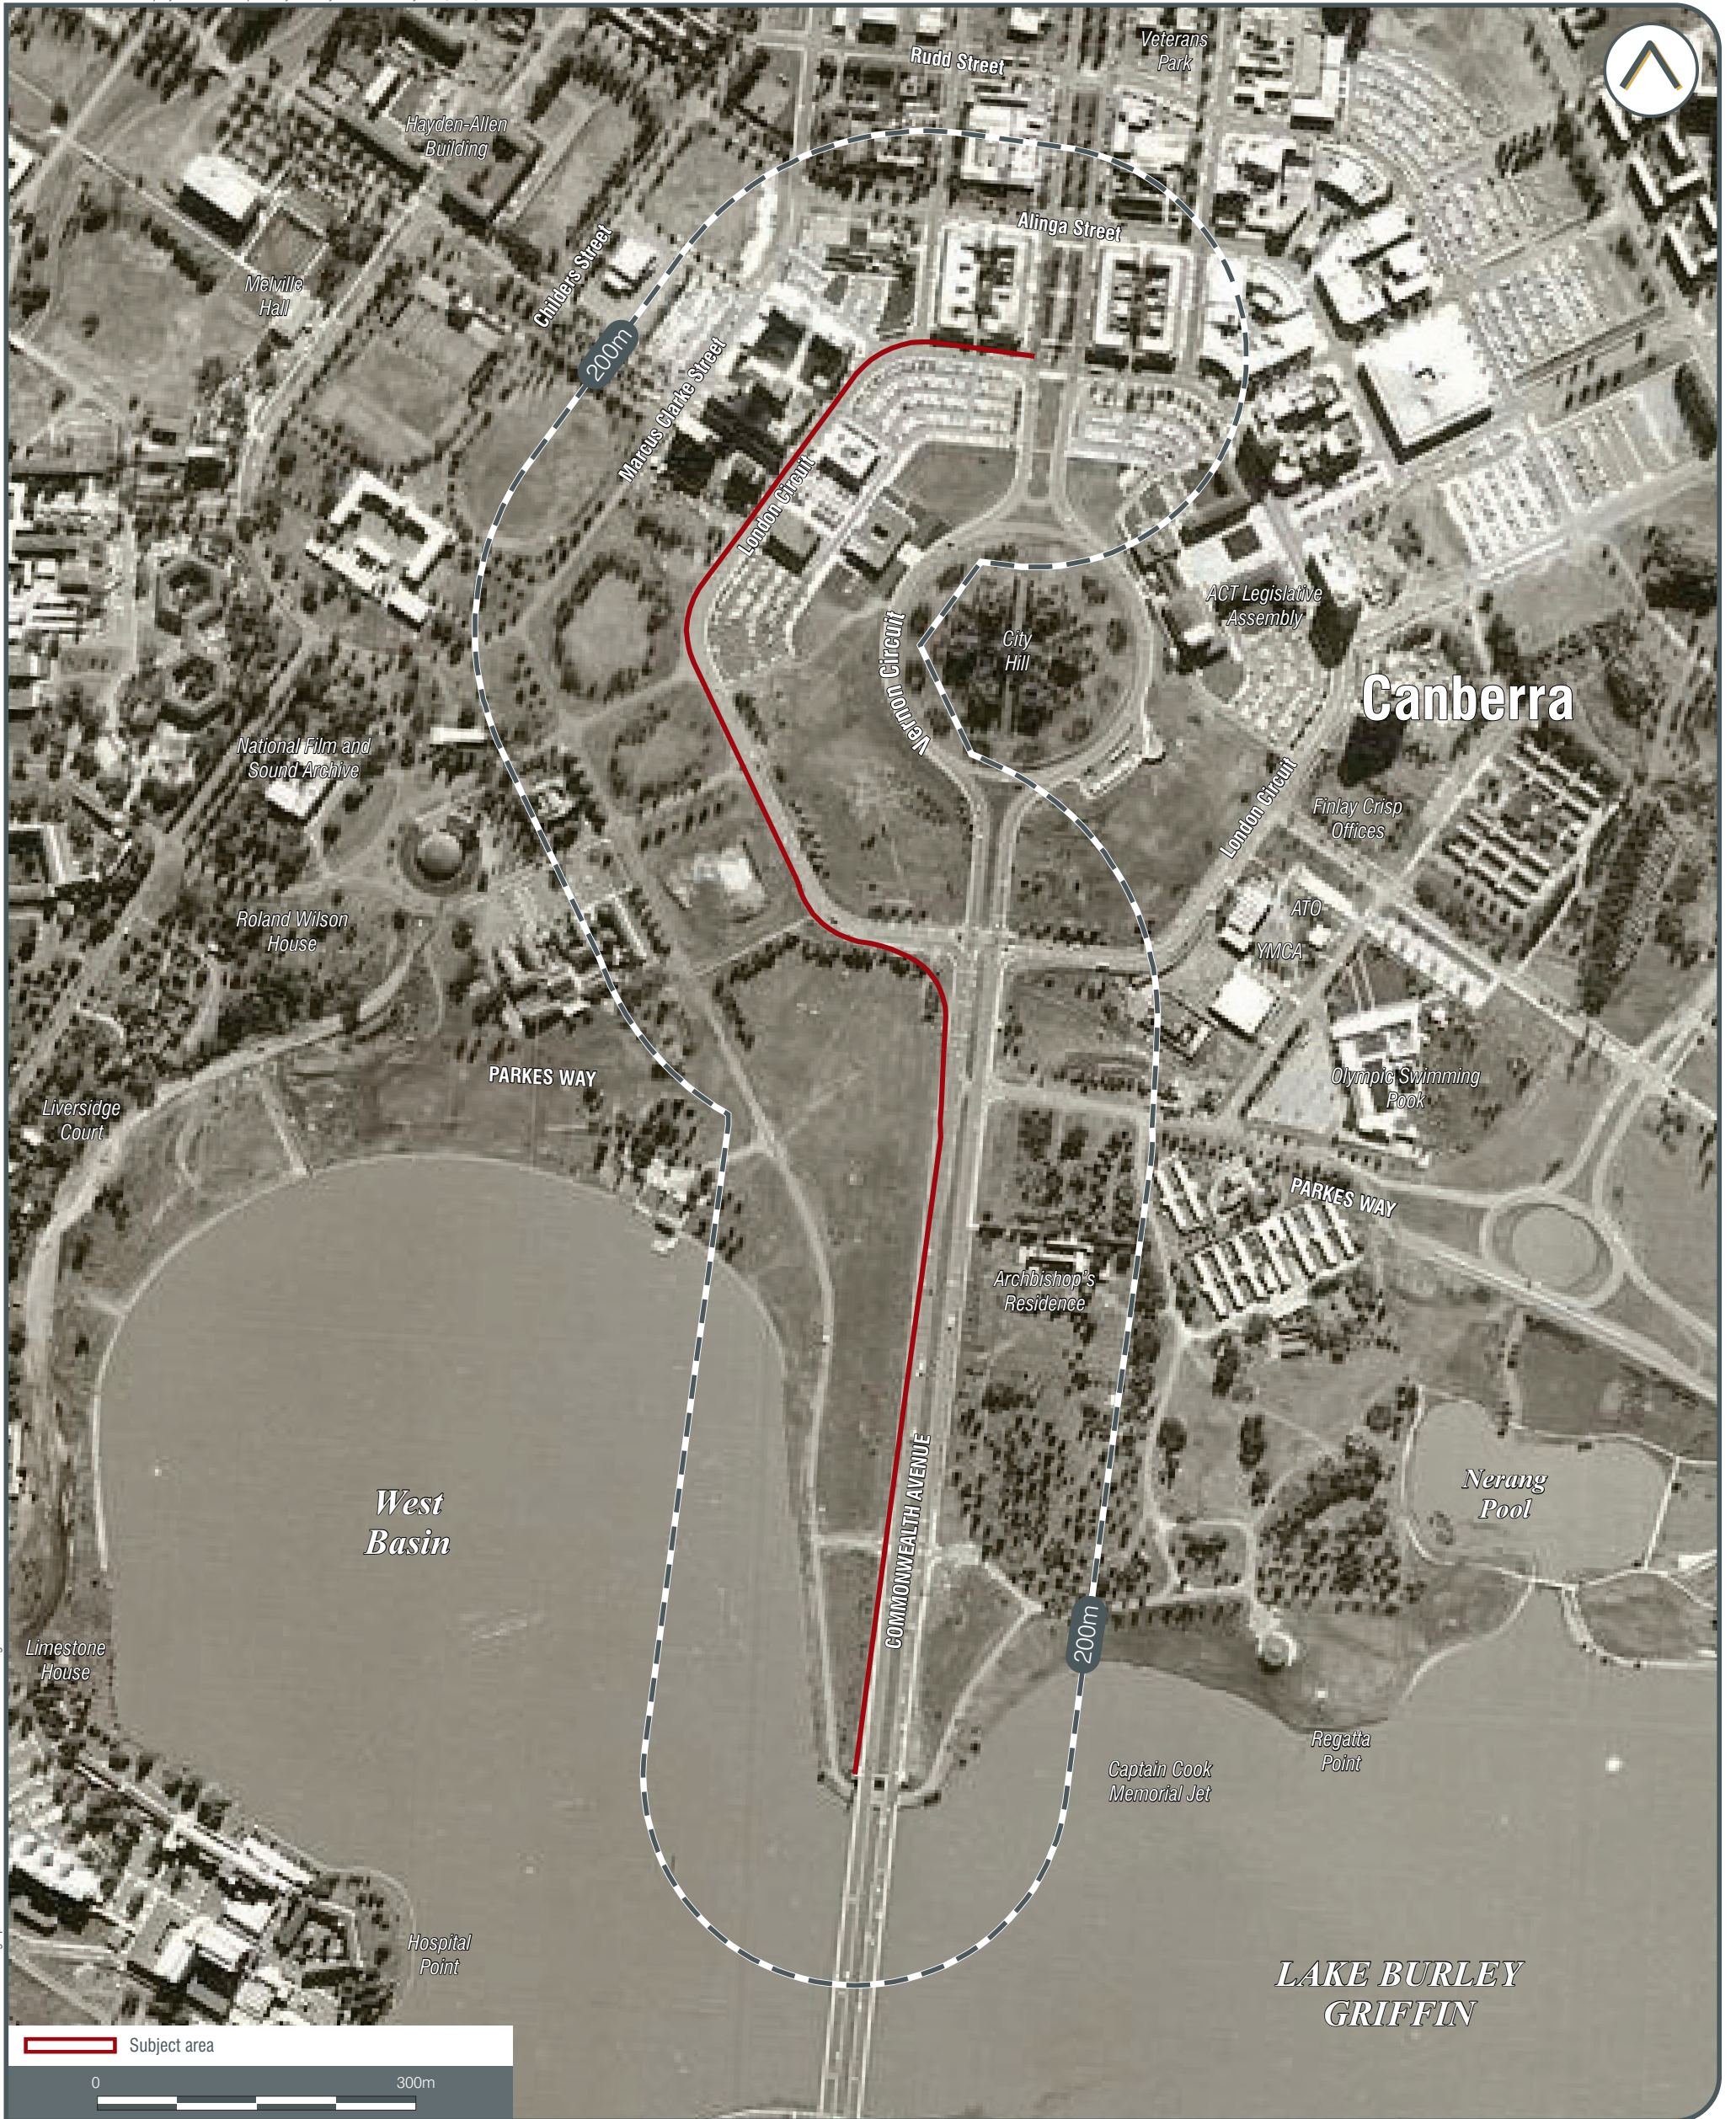
HISTORICAL AERIAL PHOTOGRAPH - 1968

1968- Black and White	<ul style="list-style-type: none"> ■ Site Area: The site appears generally consistent with previous aerial photography with the exception of London Circuit and Commonwealth Avenue which appear to have been re-sealed. ■ Surrounding Area: Lake Burley Griffin has been created to the south and southwest of the site. Car parking areas appear to have been constructed on the northern portion of London Circuit consistent with their current alignment. Commercial development has continued to occur to the north, east and west of the Site. Additional roadways have also been constructed to the east and south (beneath the Commonwealth Avenue Bridge) of the Site. The Barracks located to the east of the Site has been demolished and replaced with the eastern portion of Parkes Way.

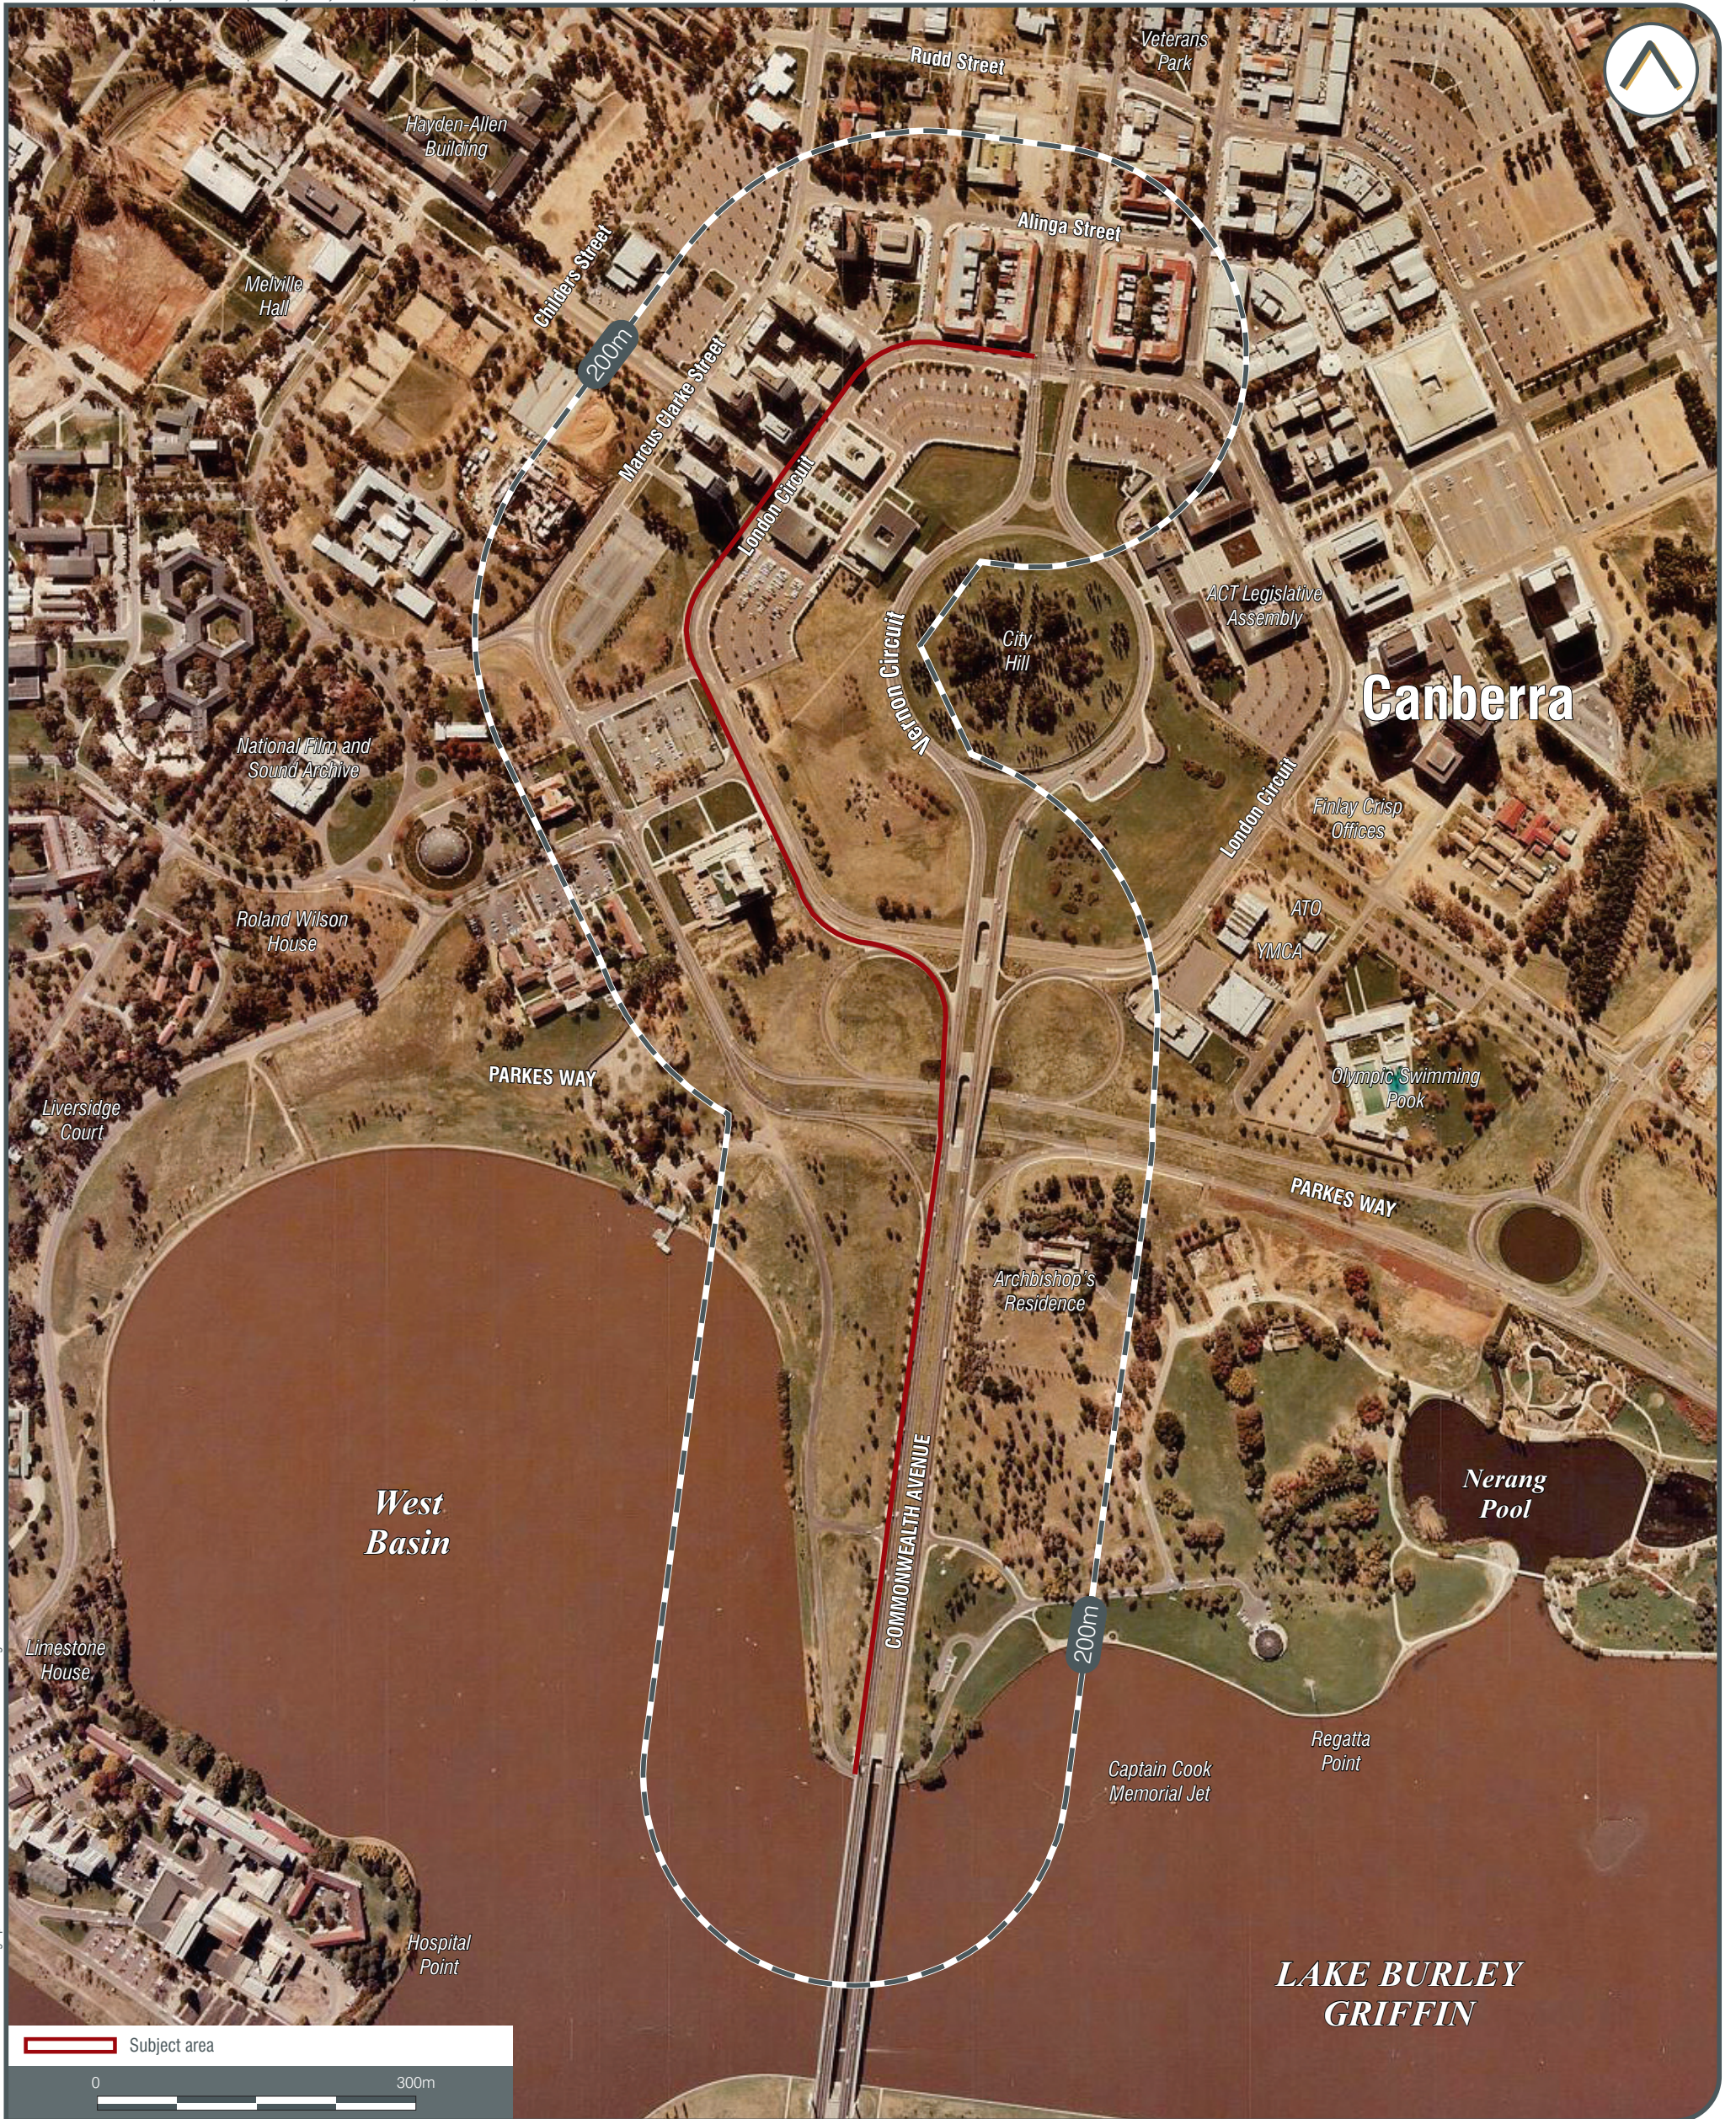
HISTORICAL AERIAL PHOTOGRAPH - 1975

Year	Description
1975 – Colour	<ul style="list-style-type: none"> ■ Site Area: The central portion of Commonwealth Avenue has been elevated with the construction of a bridge over Parkes Way. The “clover leaf” on / off ramps have been constructed within the central portion of Commonwealth Avenue to enable access to Parkes Way. The remainder of the site appears consistent with previous aerial imagery. ■ Surrounding Area: Parkes Way been expanded and includes an underpass beneath Commonwealth Avenue. Recreational areas within West Basin and the adjacent parklands to the west of the site have been developed. Additional commercial development has occurred to the west of London Circuit and expansion of the university to the east of the Site has also occurred.
1978 – Colour	<ul style="list-style-type: none"> ■ Site Area: No significant changes observable since previous aerial photography ■ Surrounding Area: The area to the west of the Site has been cleared for construction of the current Parkes Way alignment. The area to the east and west of Commonwealth Avenue (within the location of the current Commonwealth Park and Henry Rolland Park) appears to have been cleared.

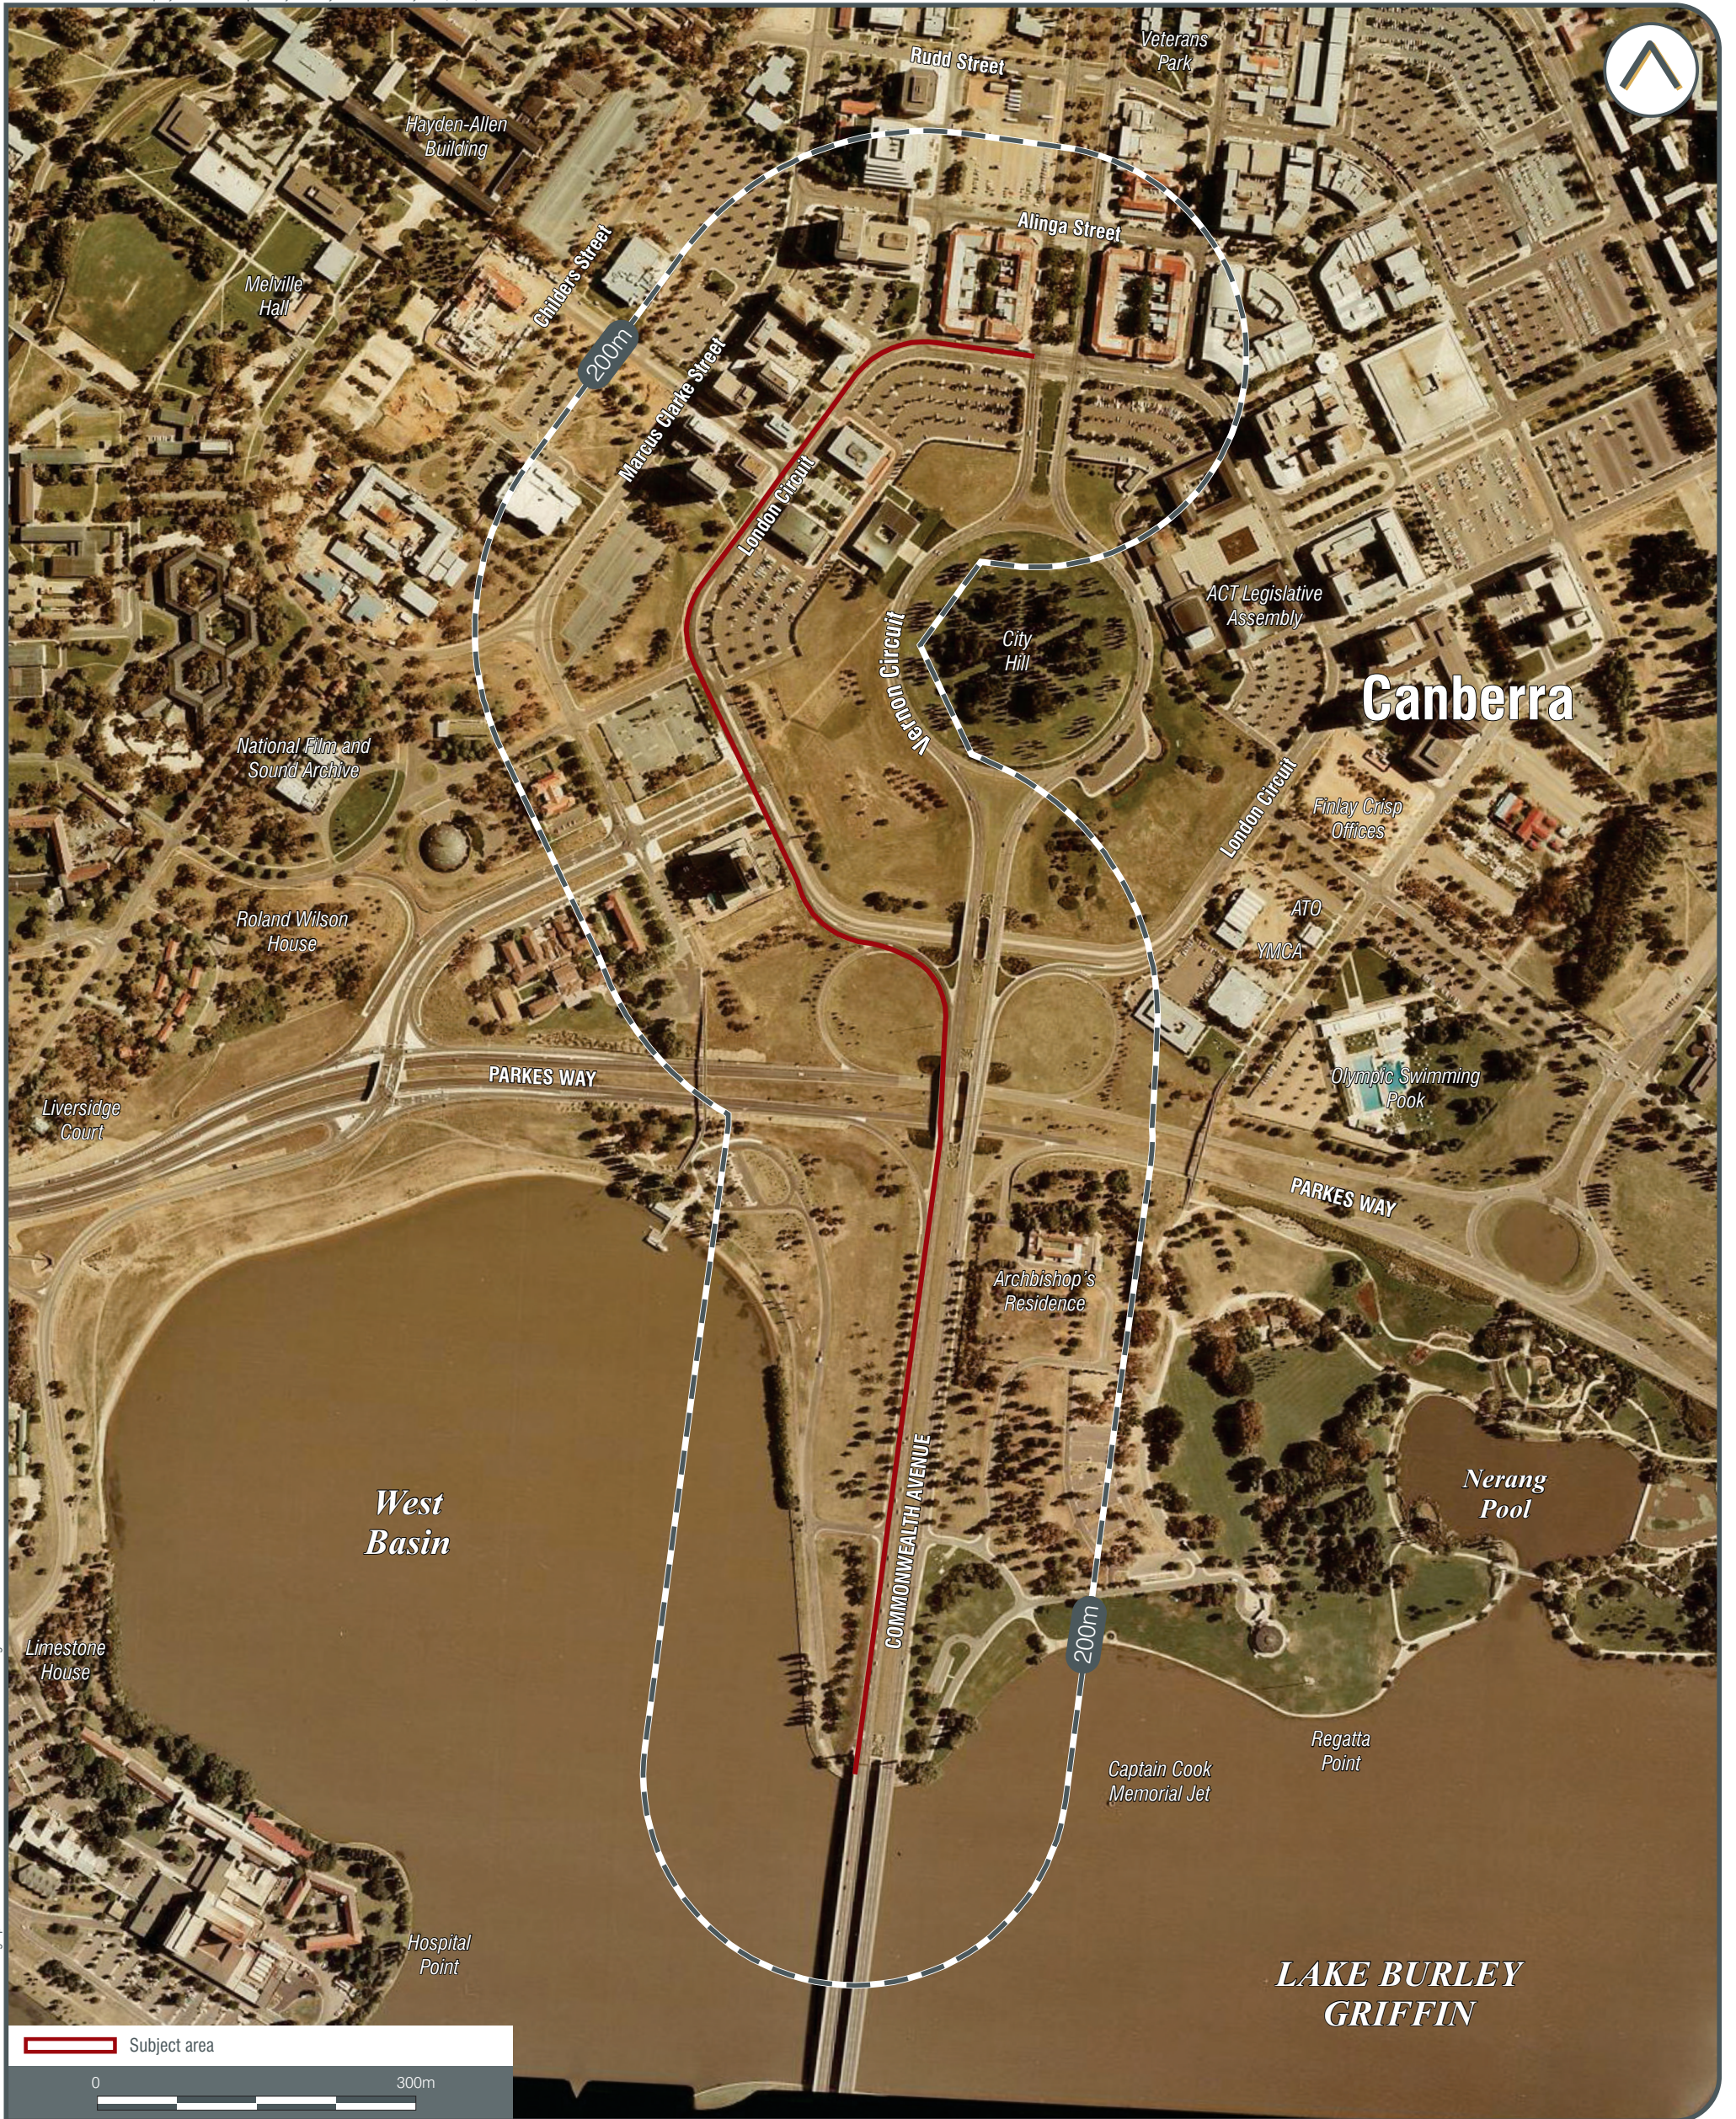
HISTORICAL AERIAL PHOTOGRAPH - 1980

1980 – Colour	<ul style="list-style-type: none"> ■ Site Area: No significant changes observable since previous aerial photography ■ Surrounding Area: The construction of Parkes Way has been completed and is consistent with its current alignment.
1986 – Colour	<ul style="list-style-type: none"> ■ Site Area: No significant changes observable since previous aerial photography ■ Surrounding Area: The area surrounding London Circuit has been developed for primarily car parking purposes. The remainder of the surrounding areas appear generally consistent with previous aerial photography.
1993 – Colour	<ul style="list-style-type: none"> ■ Site Area: No significant changes observable since previous aerial photography ■ Surrounding Area: Commercial construction has occurred to the south west of the Site and within the area surrounding City Hill. Construction of a high-rise building immediately west of the site can also be observed. Commonwealth Park appears to be consistent with the current layout including a car park to the north of Henry Rolland Park.
