Hazardous Materials Risk Assessment

Crowmell Property Services

Centenary House

19 National Circuit, Barton ACT 2600

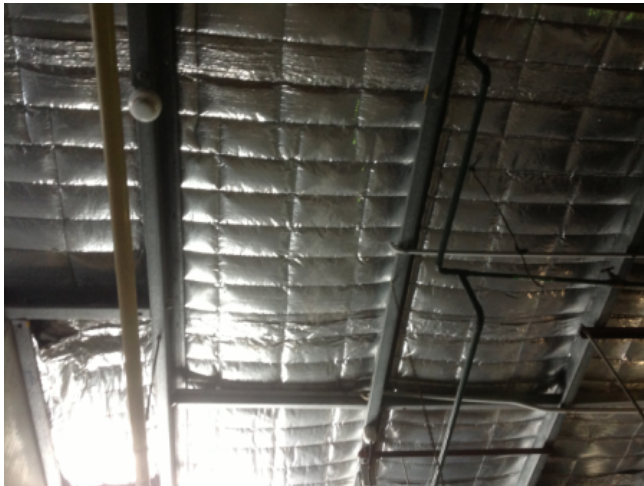
Photo No: J123625-003-CEN-755
Result: SMF - Positive
Building/Level: Office Block-Level 4
Room/Location: All rooms-Throughout
Feature/Material: Roof Lining-Sarking Insulation

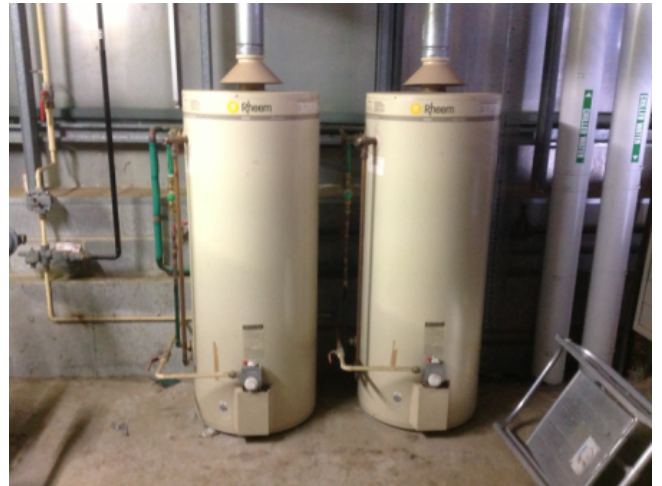
Photo No: J123625-003-CEN-756
Result: SMF - Positive
Building/Level: Office Block-Level 4
Room/Location: Boiler Room-
Feature/Material: Hot Water Service Insulation-Insulation Material

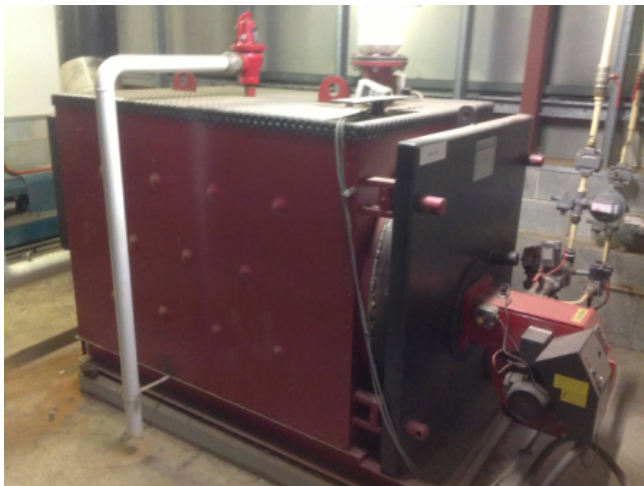
Boiler Room Pipework Flange Joint - Gasket	Asbestos	Previously Sampled NAA 76326-03-01	Assumed Negative											
Boiler Room - Central Plant & Equipment - Insulation Material - Boiler	SMF		Positive	J123625-003-C EN-757	2 Unit/s	Good	Bonded (SMF)						Maintain in good condition and incorporate into a HMMP. Remove under controlled conditions prior to demolition or refurbishment.	
Boiler Room - From boiler Duct - Insulation Material - Flue	SMF		Positive	J123625-003-C EN-758	4 m ²	Good	Bonded (SMF)						Maintain in good condition and incorporate into a HMMP. Remove under controlled conditions prior to demolition or refurbishment.	
Lift Motor Room - Lift No.'s 1 & 2 Lift Motor - Brake Pads	Asbestos	Not Sampled - Live Electricity	Presumed Positive	J123625-003-C EN-754	2 Unit/s	Good	Non Friable	Low	Low	Suspect	18-12-2018	P4	Confirm status, maintain in current condition and incorporate into an HMMP. Remove by licensed asbestos contractor prior to demolition or refurbishment.

Photo No: J123625-003-CEN-757
Result: SMF - Positive
Building/Level: Office Block-Level 4
Room/Location: Boiler Room-Central
Feature/Material: Plant & Equipment-Insulation Material

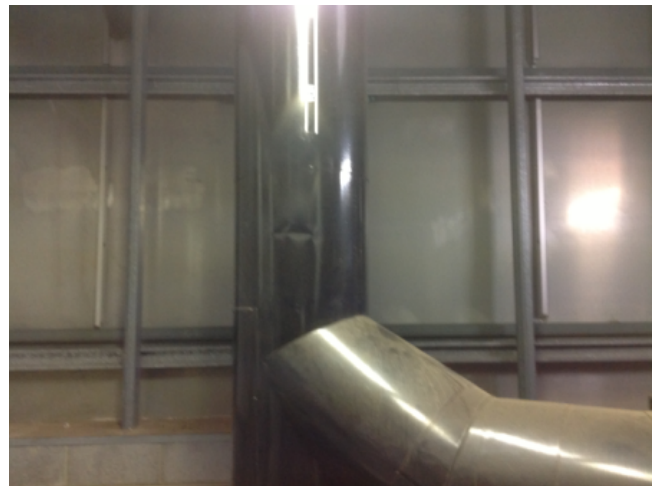
Photo No: J123625-003-CEN-758
Result: SMF - Positive
Building/Level: Office Block-Level 4
Room/Location: Boiler Room-From boiler
Feature/Material: Duct-Insulation Material

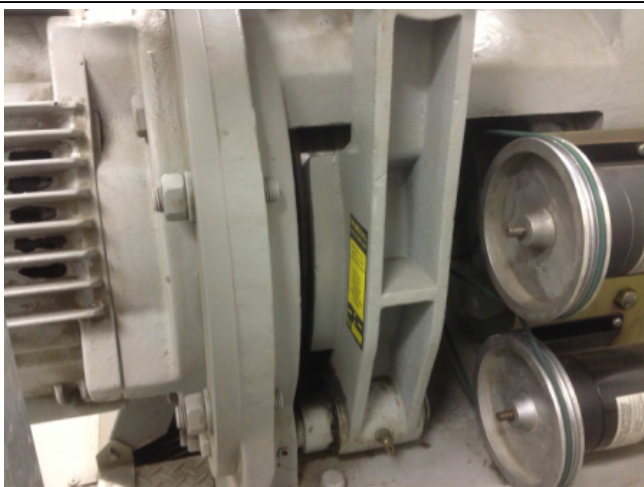
Photo No: J123625-003-CEN-754
Result: Asbestos - Presumed Positive
Building/Level: Office Block-Level 4
Room/Location: Lift Motor Room-Lift No.'s 1 & 2
Feature/Material: Lift Motor-Brake Pads

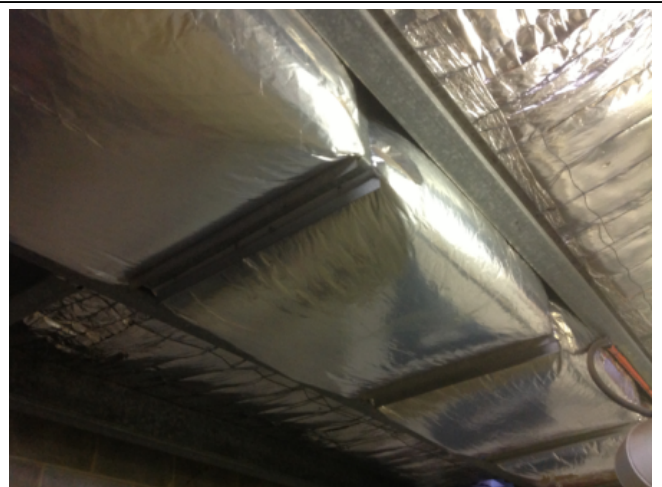
Photo No: J123625-003-CEN-760
Result: SMF - Positive
Building/Level: Office Block-Level 4
Room/Location: Plant Rooms-Variou Throughout
Feature/Material: Ductwork Insulation-Insulation Material

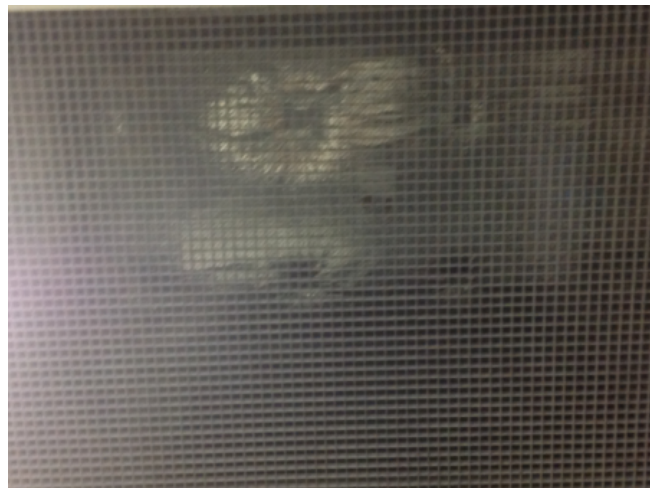
Photo No: J123625-003-CEN-766
 Result: SMF - Positive
 Building/Level: Office Block-Level 3
 Room/Location: Ceiling Space-Variou Throughout
 Feature/Material: Ductwork Insulation-Insulation Material

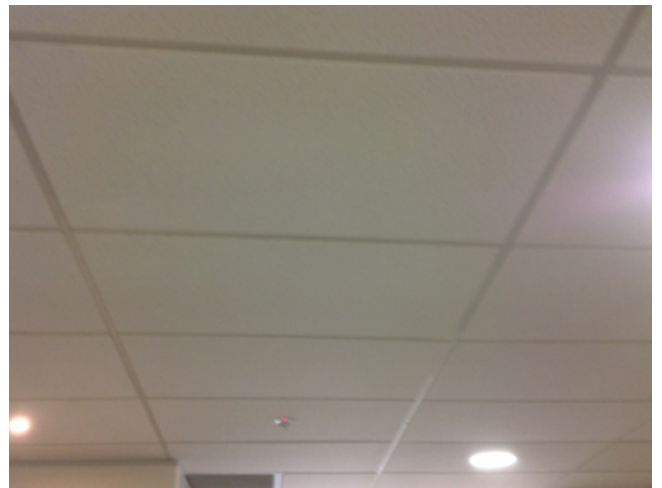
Photo No: J123625-003-CEN-765
 Result: SMF - Positive
 Building/Level: Office Block-Level 3
 Room/Location: Office Areas-Throughout
 Feature/Material: Ceiling Tiles-Compressed Ceiling Tiles

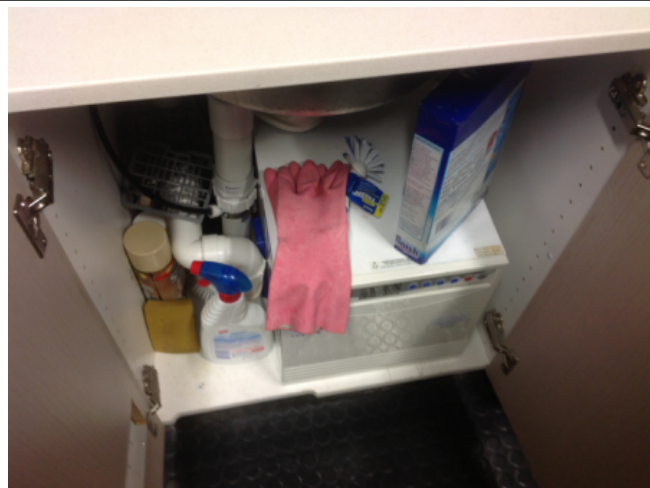
Office Kitchens - Below sink Hot Water Service Insulation - Insulation Material	SMF		Positive	J123625-003-C EN-769	2 Unit/s	Good	Bonded (SMF)						Maintain in good condition and incorporate into a HMMP. Remove under controlled conditions prior to demolition or refurbishment.	
Plant Room No.7 - Cable Penetrations - Packing	Asbestos	Previously Sampled NAA 201087490-03-01	Negative											
Plant Room No.7 - Loose Stored Item - Insulation Material	SMF		Positive	J123625-003-C EN-768	2 m ²	Poor	Bonded (SMF)						Access to exposed/damaged materials should be restricted. Engage an appropriately experienced contractor to undertake remedial/removal works.	
Plant Room No.8 - Redundant Plant Duct - Insulation Material	SMF		Positive	J123625-003-C EN-767	2 m ²	Poor	Bonded (SMF)						Access to exposed/damaged materials should be restricted. Engage an appropriately experienced contractor to undertake remedial/removal works.

Photo No: J123625-003-CEN-769
 Result: SMF - Positive
 Building/Level: Office Block-Level 3
 Room/Location: Office Kitchens-Below sink
 Feature/Material: Hot Water Service Insulation-Insulation Material

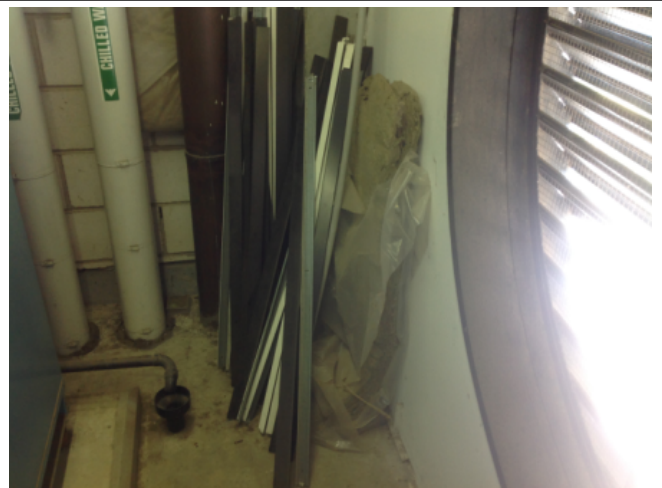
Photo No: J123625-003-CEN-768
 Result: SMF - Positive
 Building/Level: Office Block-Level 3
 Room/Location: Plant Room No.7-Loose
 Feature/Material: Stored Item-Insulation Material

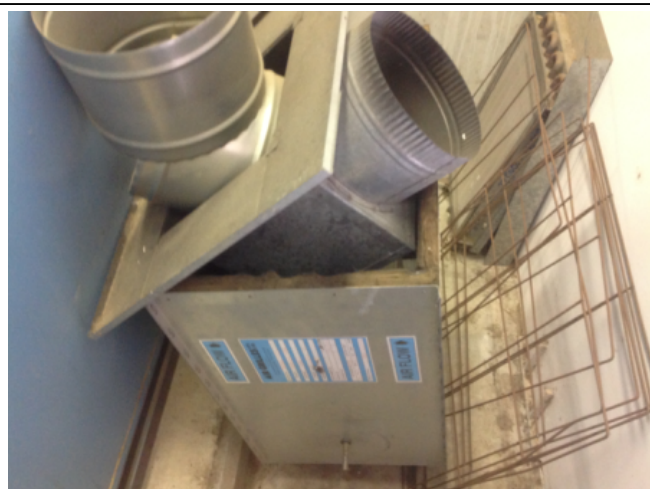
Photo No: J123625-003-CEN-767
 Result: SMF - Positive
 Building/Level: Office Block-Level 3
 Room/Location: Plant Room No.8-Redundant Plant
 Feature/Material: Duct-Insulation Material

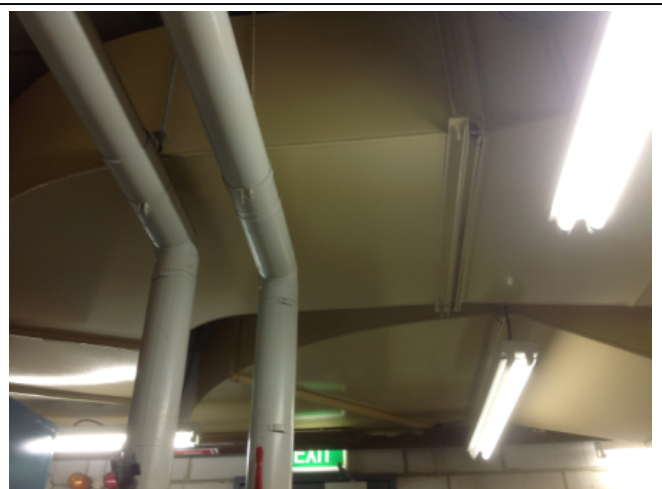
Plant Rooms No.7 & No.8 - A/C Ductwork Insulation - Insulation Material	SMF		Positive	J123625-003-C EN-764	10 m ²	Good	Bonded (SMF)						Maintain in good condition and incorporate into a HMMP. Remove under controlled conditions prior to demolition or refurbishment.	
Plant Rooms No.7 & No.8 - AHU Plant & Equipment - Insulation Material	SMF		Positive	J123625-003-C EN-763	2 Unit/s	Good	Bonded (SMF)						Maintain in good condition and incorporate into a HMMP. Remove under controlled conditions prior to demolition or refurbishment.	
Plant Rooms No.7 & No.8 - Around Vent Wall - Dividing - Fibre Cement Sheeting	Asbestos	Previously Sampled NAA same as 76326-03-04	Assumed Negative

Photo No: J123625-003-CEN-764
 Result: SMF - Positive
 Building/Level: Office Block-Level 3
 Room/Location: Plant Rooms No.7 & No.8-A/C
 Feature/Material: Ductwork Insulation-Insulation Material

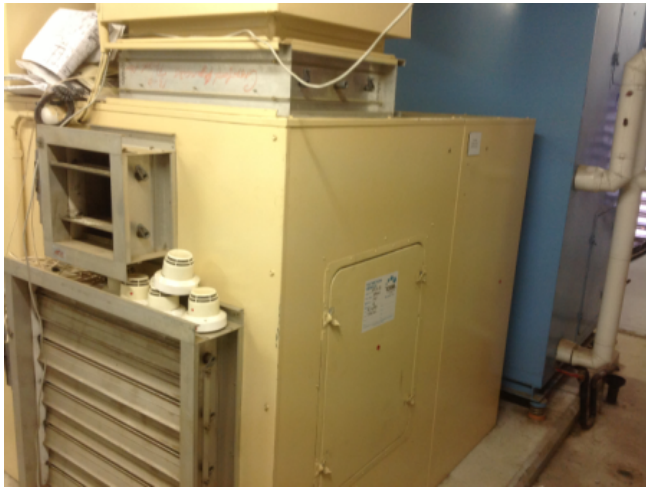
Photo No: J123625-003-CEN-763
 Result: SMF - Positive
 Building/Level: Office Block-Level 3
 Room/Location: Plant Rooms No.7 & No.8-AHU
 Feature/Material: Plant & Equipment-Insulation Material

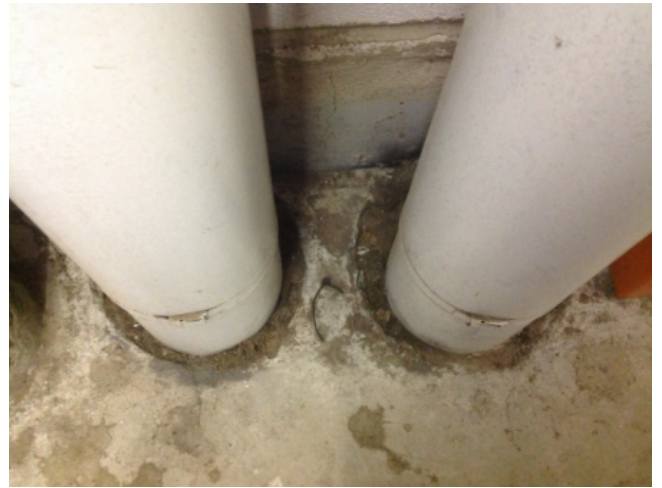
Photo No: J123625-003-CEN-761
 Result: SMF - Positive
 Building/Level: Office Block-Level 3
 Room/Location: Plant Rooms No.7 & No.8-Ceiling & floor - Pipes
 Feature/Material: Penetrations-Loose Insulation

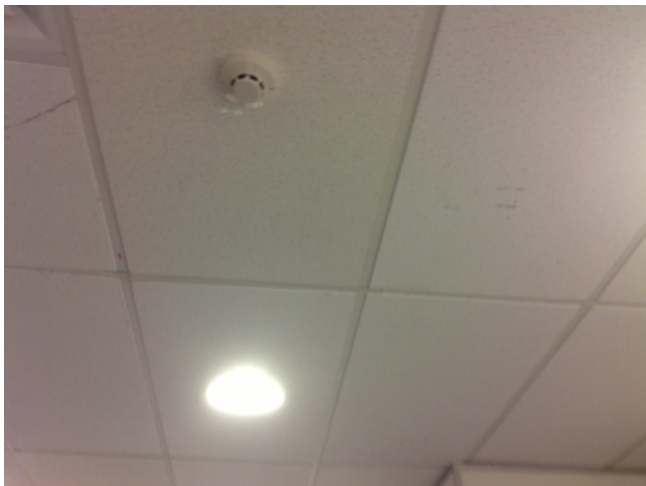
Photo No: J123625-003-CEN-770
 Result: SMF - Positive
 Building/Level: Office Block-Level 2
 Room/Location: Office Areas-Throughout
 Feature/Material: Ceiling Tiles-Compressed Ceiling Tiles

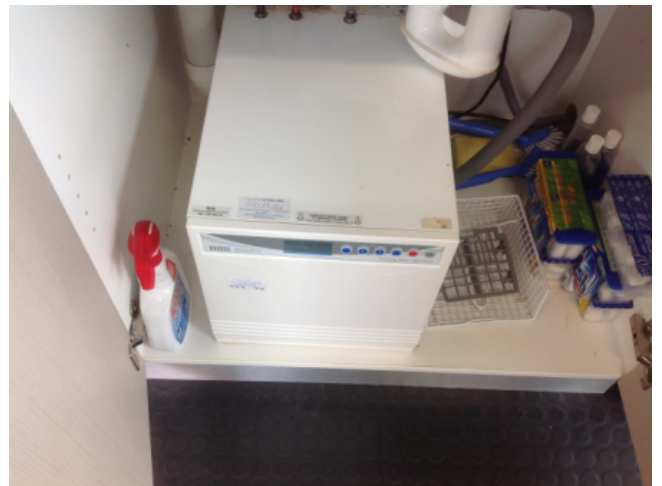
Office Kitchens - Below sink Hot Water Service Insulation - Insulation Material	SMF		Positive	J123625-003-C EN-775	2 Unit/s	Good	Bonded (SMF)						Maintain in good condition and incorporate into a HMMP. Remove under controlled conditions prior to demolition or refurbishment.	
Plant Rooms No.5 & No.6 - A/C Ductwork Insulation - Insulation Material	SMF		Positive	J123625-003-C EN-772	30 m ²	Good	Bonded (SMF)						Maintain in good condition and incorporate into a HMMP. Remove under controlled conditions prior to demolition or refurbishment.	
Plant Rooms No.5 & No.6 - AHU Plant & Equipment - Insulation Material	SMF		Positive	J123625-003-C EN-771	2 Unit/s	Good	Bonded (SMF)						Maintain in good condition and incorporate into a HMMP. Remove under controlled conditions prior to demolition or refurbishment.	
Plant Rooms No.5 & No.6 - Around Vent Wall - Dividing - Fibre Cement Sheeting	Asbestos	Previously Sampled NAA 76326-03-04	Assumed Negative

Photo No: J123625-003-CEN-775
 Result: SMF - Positive
 Building/Level: Office Block-Level 2
 Room/Location: Office Kitchens-Below sink
 Feature/Material: Hot Water Service Insulation-Insulation Material

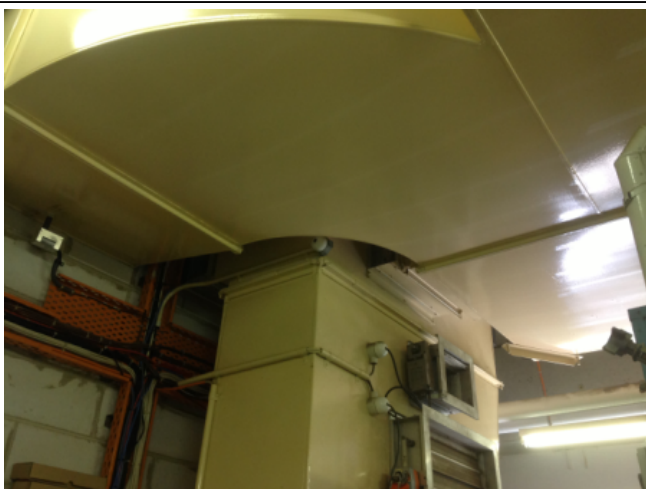
Photo No: J123625-003-CEN-772
 Result: SMF - Positive
 Building/Level: Office Block-Level 2
 Room/Location: Plant Rooms No.5 & No.6-A/C
 Feature/Material: Ductwork Insulation-Insulation Material

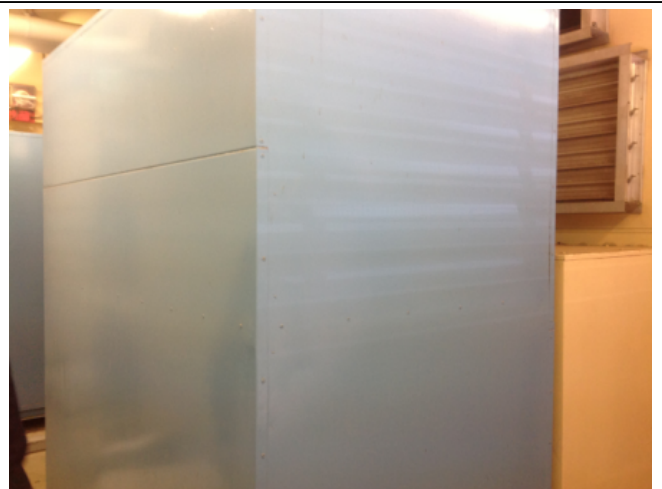
Photo No: J123625-003-CEN-771
 Result: SMF - Positive
 Building/Level: Office Block-Level 2
 Room/Location: Plant Rooms No.5 & No.6-AHU
 Feature/Material: Plant & Equipment-Insulation Material

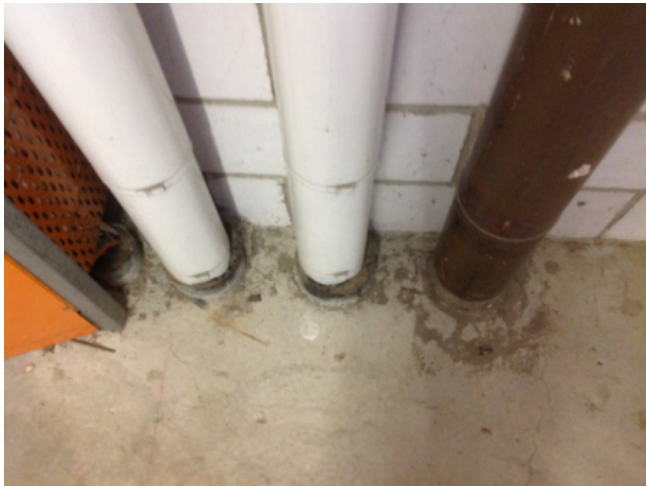
Plant Rooms No.5 & No.6 - Ceiling & floor - Pipes Penetrations - Loose Insulation	SMF		Positive	J123625-003-C EN-773	1 m ²	Good	Unbonded (SMF)						Maintain in good condition and incorporate into a HMMP. Remove under controlled conditions prior to demolition or refurbishment.	
Plant Rooms No.5 & No.6 - Walls - Ductwork Penetrations - Loose Insulation	SMF		Positive	J123625-003-C EN-774	4 m ²	Good	Unbonded (SMF)						Maintain in good condition and incorporate into a HMMP. Remove under controlled conditions prior to demolition or refurbishment.	
Office Block - Interior - Level 1														
Ceiling Space - A/C Ductwork Insulation - Insulation Material	SMF		Positive		50 m ²	Good	Bonded (SMF)						Maintain in good condition and incorporate into a HMMP. Remove under controlled conditions prior to demolition or refurbishment.	
Office Areas - Throughout Ceiling Tiles - Compressed Ceiling Tiles	SMF		Positive	J123625-003-C EN-779	1000 m ²	Good	Bonded (SMF)						Maintain in good condition and incorporate into a HMMP. Remove under controlled conditions prior to demolition or refurbishment.

Photo No: J123625-003-CEN-773
Result: SMF - Positive
Building/Level: Office Block-Level 2
Room/Location: Plant Rooms No.5 & No.6-Ceiling & floor - Pipes
Feature/Material: Penetrations-Loose Insulation

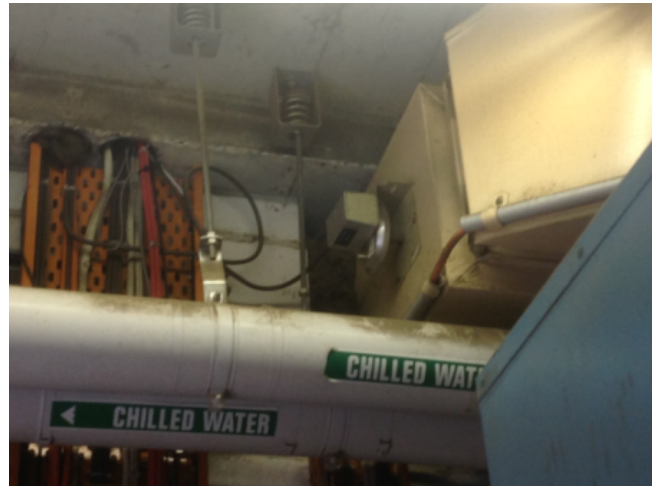
Photo No: J123625-003-CEN-774
Result: SMF - Positive
Building/Level: Office Block-Level 2
Room/Location: Plant Rooms No.5 & No.6-Walls - Ductwork
Feature/Material: Penetrations-Loose Insulation

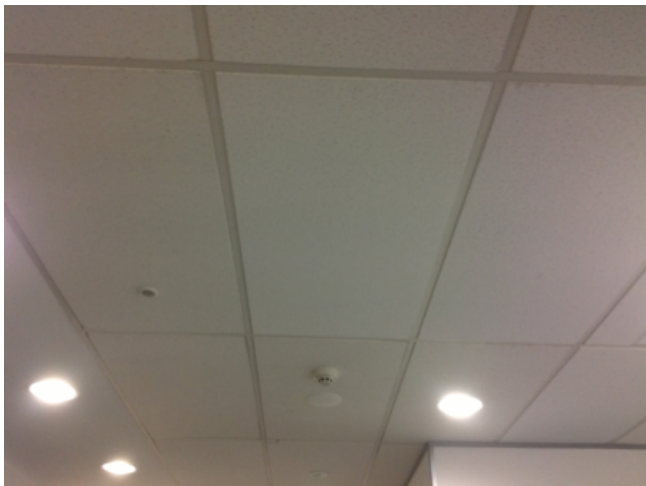
Photo No: J123625-003-CEN-779
Result: SMF - Positive
Building/Level: Office Block-Level 1
Room/Location: Office Areas-Throughout
Feature/Material: Ceiling Tiles-Compressed Ceiling Tiles

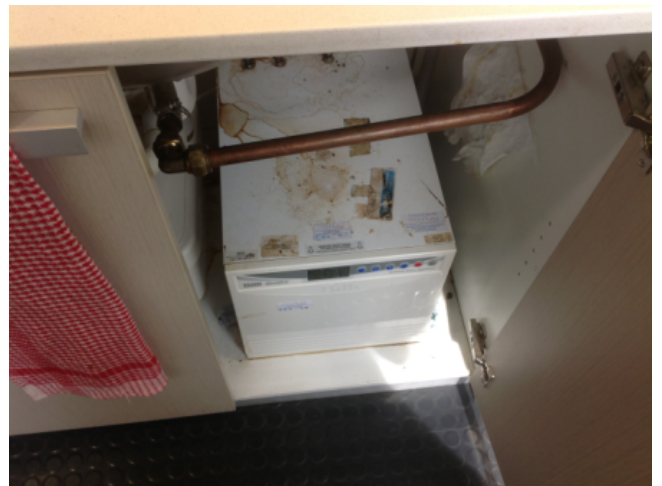
Photo No: J123625-003-CEN-780
Result: SMF - Positive
Building/Level: Office Block-Level 1
Room/Location: Office Kitchens-Below sink
Feature/Material: Hot Water Service Insulation-Insulation Material

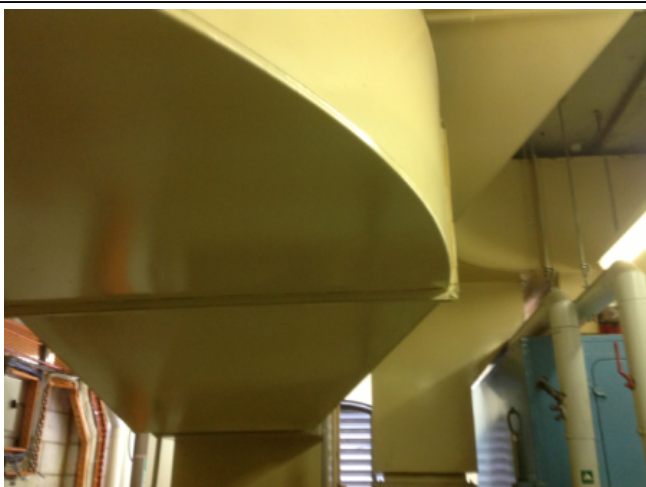
Photo No: J123625-003-CEN-778
Result: SMF - Positive
Building/Level: Office Block-Level 1
Room/Location: Plant Rooms No.3 & No.4-A/C
Feature/Material: Ductwork Insulation-Insulation Material

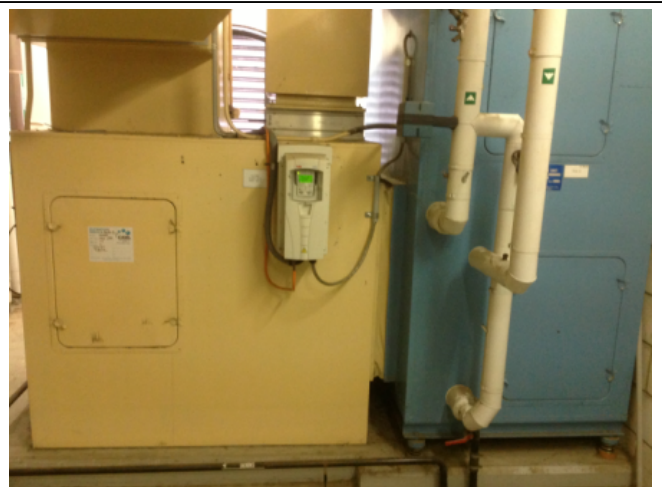
Photo No: J123625-003-CEN-777
Result: SMF - Positive
Building/Level: Office Block-Level 1
Room/Location: Plant Rooms No.3 & No.4-AHU
Feature/Material: Plant & Equipment-Insulation Material

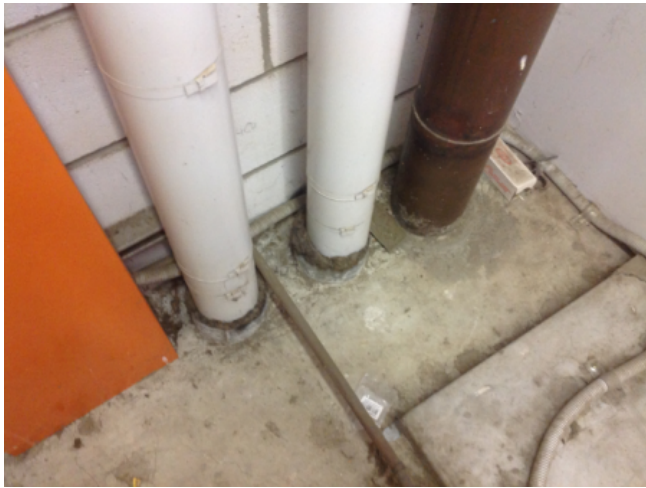
Photo No: J123625-003-CEN-776
 Result: SMF - Positive
 Building/Level: Office Block-Level 1
 Room/Location: Plant Rooms No.3 & No.4-Ceiling & floor - Pipes
 Feature/Material: Penetrations-Loose Insulation

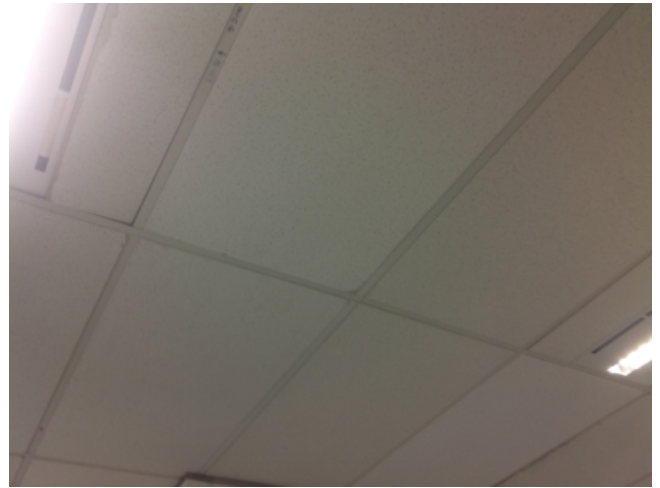
Photo No: J123625-003-CEN-784
 Result: SMF - Positive
 Building/Level: Office Block-Ground Level
 Room/Location: Office Areas-Throughout
 Feature/Material: Ceiling Tiles-Compressed Ceiling Tiles

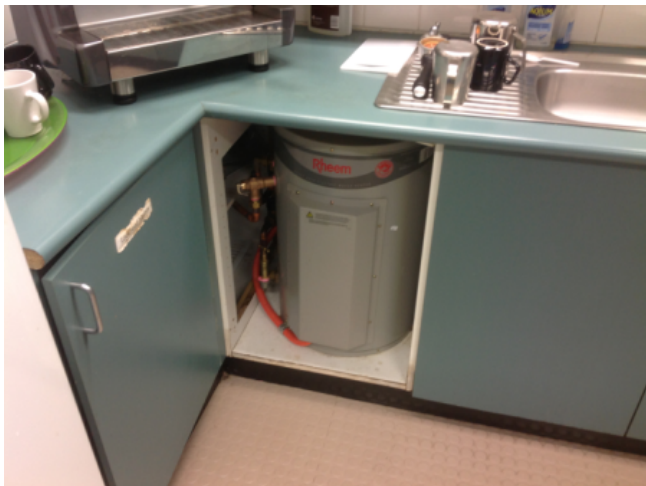
Photo No: J123625-003-CEN-785
 Result: SMF - Positive
 Building/Level: Office Block-Ground Level
 Room/Location: Office Kitchens-Below sink
 Feature/Material: Hot Water Service Insulation-Insulation Material

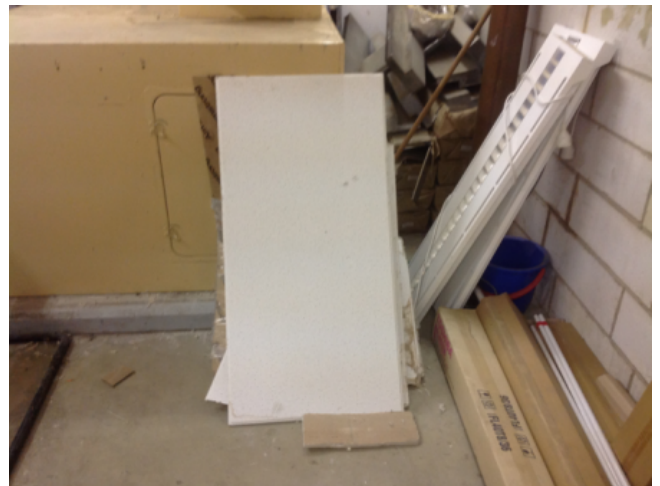
Photo No: J123625-003-CEN-786
 Result: SMF - Positive
 Building/Level: Office Block-Ground Level
 Room/Location: Plant Room No.2-
 Feature/Material: Stored Item-Compressed Ceiling Tiles

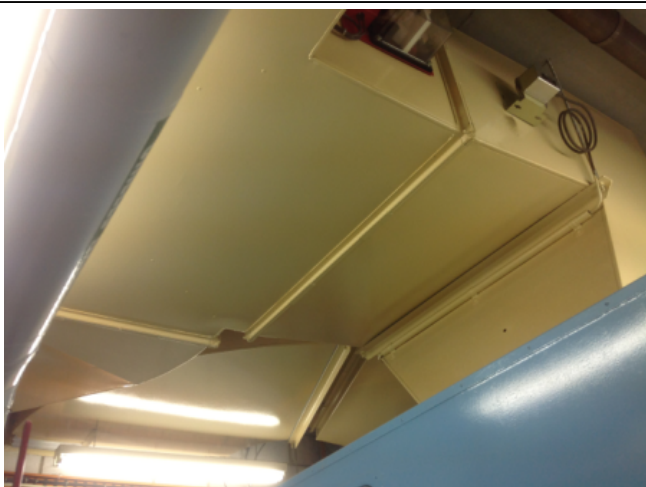
Photo No: J123625-003-CEN-783
 Result: SMF - Positive
 Building/Level: Office Block-Ground Level
 Room/Location: Plant Rooms No.1 & No.2-A/C
 Feature/Material: Ductwork Insulation-Insulation Material

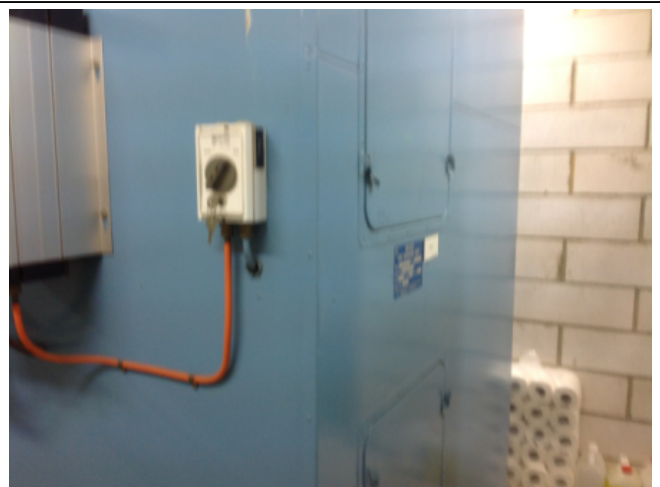
Photo No: J123625-003-CEN-782
 Result: SMF - Positive
 Building/Level: Office Block-Ground Level
 Room/Location: Plant Rooms No.1 & No.2-AHU
 Feature/Material: Plant & Equipment-Insulation Material

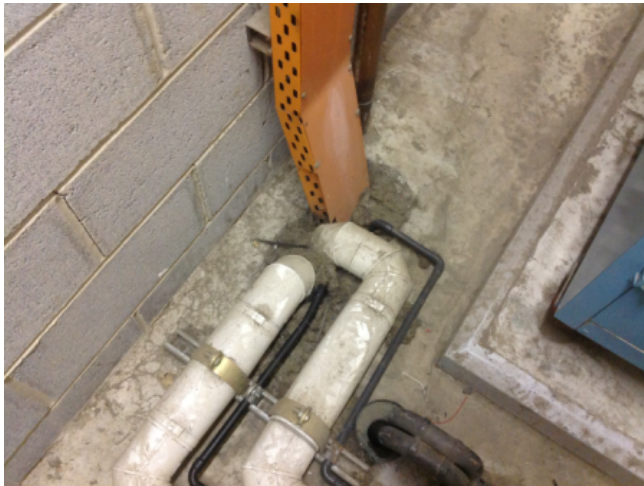
Plant Rooms No.1 & No.2 - Ceiling & floor - Pipes Penetrations - Loose Insulation	SMF		Positive	J123625-003-C EN-781	1 m ²	Good	Unbonded (SMF)						Maintain in good condition and incorporate into a HMMP. Remove under controlled conditions prior to demolition or refurbishment.	
Office Block - Interior - Basement Level														
Car Park - A/C Ductwork Insulation - Insulation Material	SMF		Positive	J123625-003-C EN-788	50 m ²	Good	Bonded (SMF)						Maintain in good condition and incorporate into a HMMP. Remove under controlled conditions prior to demolition or refurbishment.	
Main Switch Room - Cables Penetrations - Pillow Insulation - Fire seals	SMF		Positive	J123625-003-C EN-787	5 Unit/s	Good	Bonded (SMF)						Maintain in good condition and incorporate into a HMMP. Remove under controlled conditions prior to demolition or refurbishment.	
Toilets Cubicle Partitions - Compressed Cement Sheeting	Asbestos	Previously Sampled NAA same as 76326-03-03	Assumed Negative

Photo No: J123625-003-CEN-781
Result: SMF - Positive
Building/Level: Office Block-Ground Level
Room/Location: Plant Rooms No.1 & No.2-Ceiling & floor - Pipes
Feature/Material: Penetrations-Loose Insulation

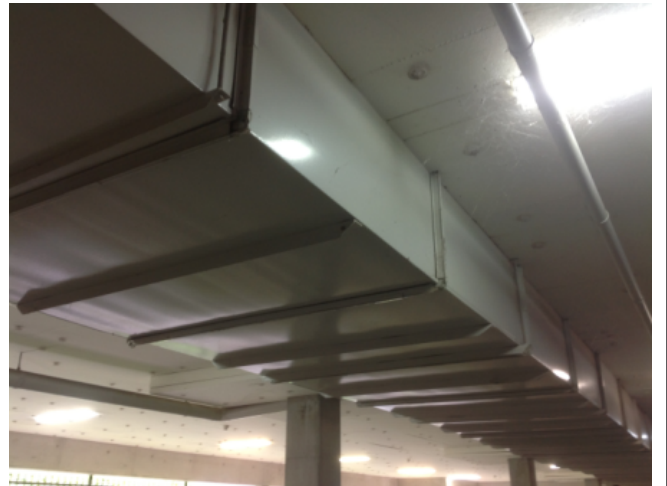
Photo No: J123625-003-CEN-788
Result: SMF - Positive
Building/Level: Office Block-Basement Level
Room/Location: Car Park-A/C
Feature/Material: Ductwork Insulation-Insulation Material

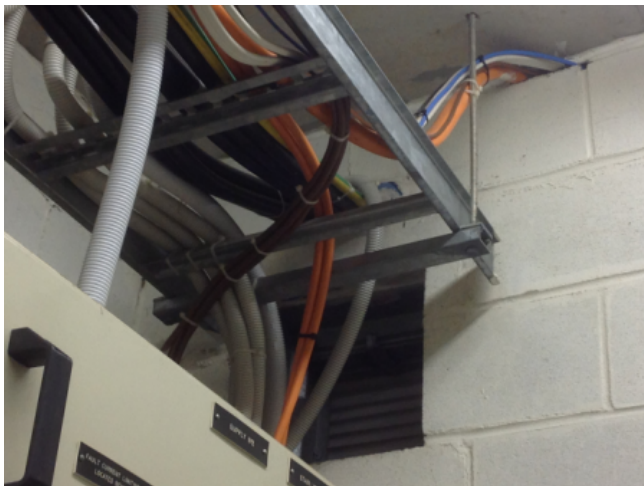
Photo No: J123625-003-CEN-787
Result: SMF - Positive
Building/Level: Office Block-Basement Level
Room/Location: Main Switch Room-Cables
Feature/Material: Penetrations-Pillow Insulation
