Appendix E – Maritime Lake Wall Assessment

Project title	City to the Lake West Basin	Job number
		240073
cc	Nathan Greig (LDA), Ian Wood-Bradley (LDA)	File reference
		MAR-MEMO-001
Prepared by	Sam Isaacs	Date
		20 February 2015
Subject	Condition of the existing West Basin lake wall structure and integration within the Stage 1A works

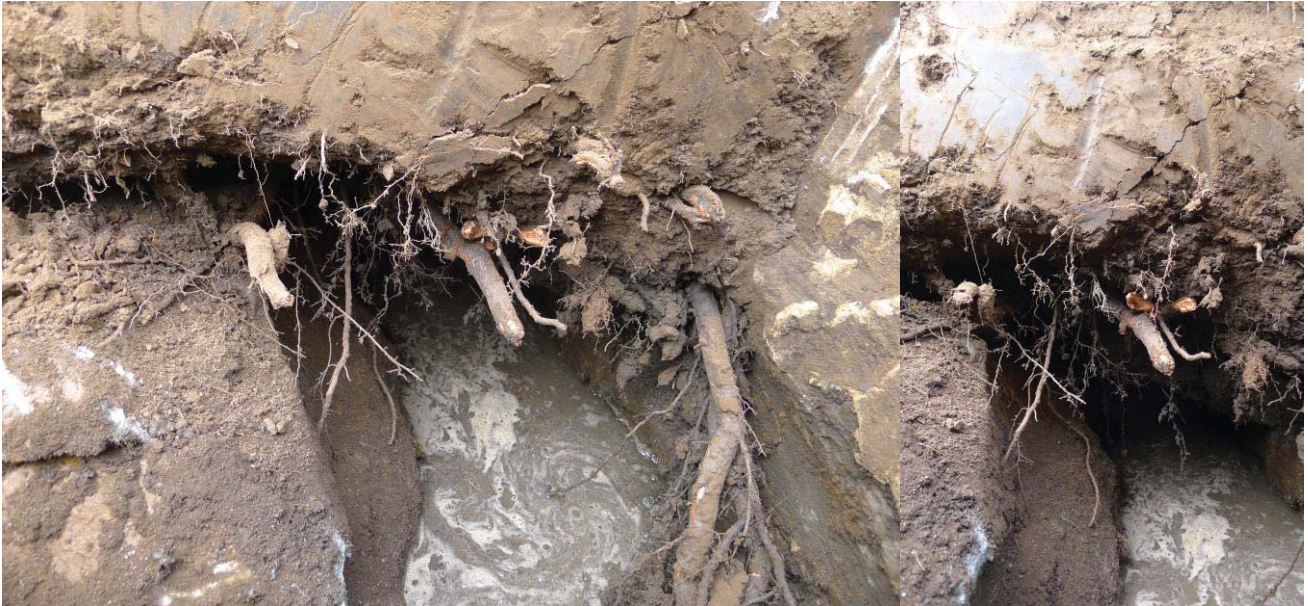
As shown in Figure 4 trial pit two revealed an extensive root network and a large void under the wall.

Figure 4 - Root network and void within Trial Pit 2

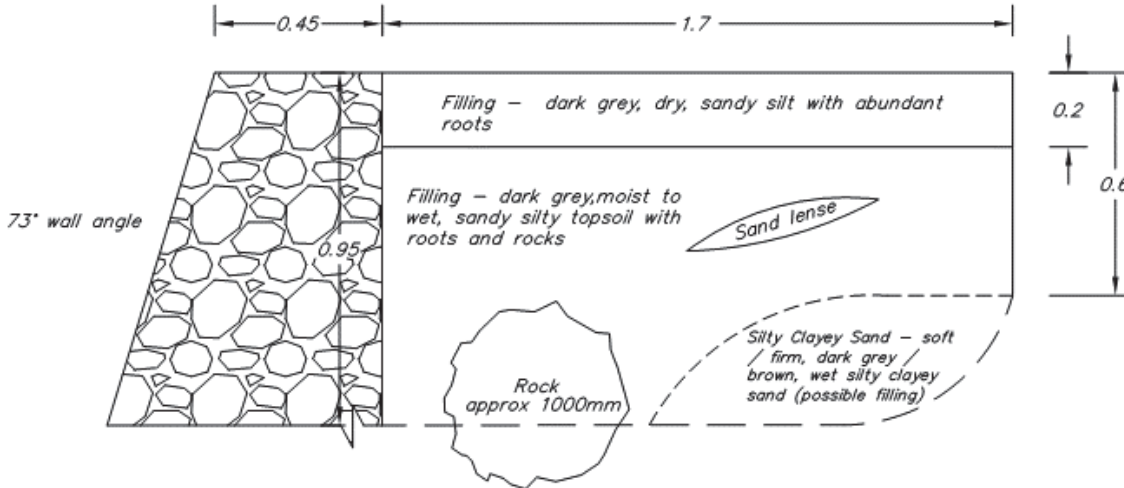
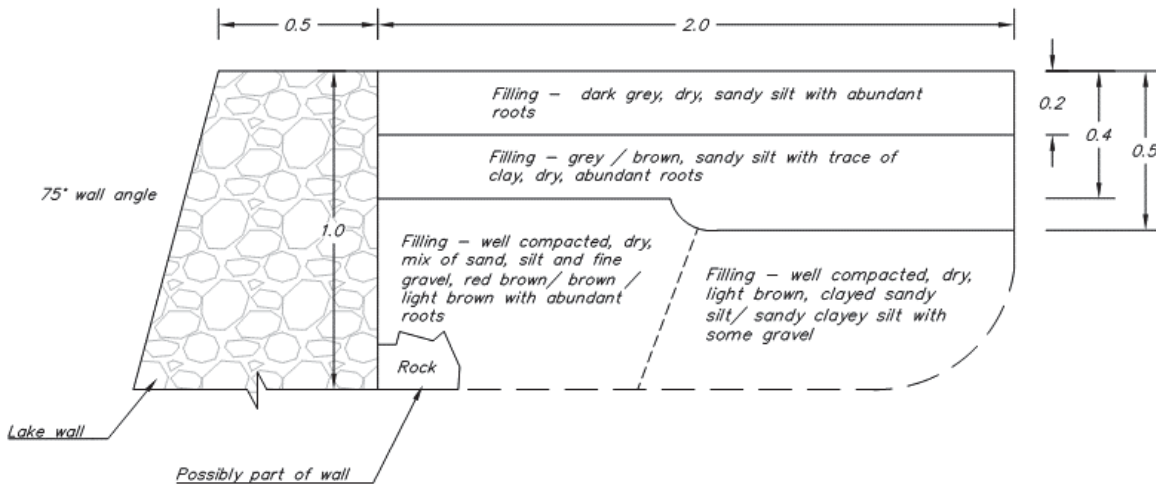
The trial pit investigation identified the existing lake wall front face as angled 73 to 75 degrees from the horizontal, with an assumed vertical rear face. No steps or other footings to the rear face of the wall were identified during the trial pit and the base of the wall was not reached. The crest width of the wall was measured and varied between 0.45m and 0.5m across the two trial pits.

The test pits did not encounter any porous back fill material behind the wall as identified in the historic drawings, with the exception of a few large rocks. There was a considerable difference in the insitu strength and moisture content between the two test pits. The insitu strength of the soil at Pit 1 was firm to stiff whilst at Pit 2 it was of hard consistency.

Figure 5 - Test Pit Cross Sections (source: Douglas Partners)

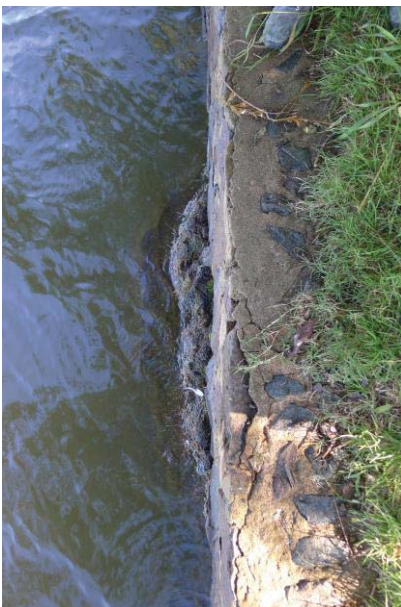
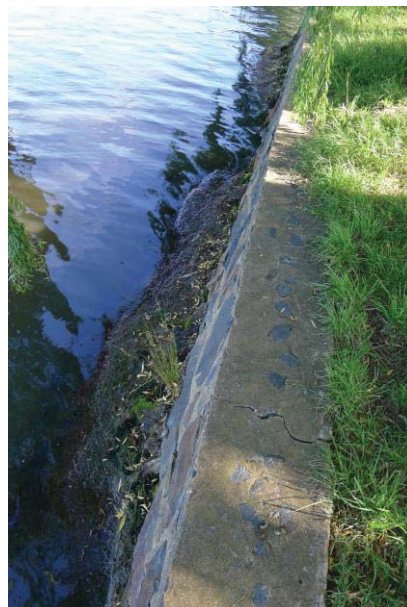
In many locations along the wall tree roots from flora growing on the landside of the wall penetrate through the wall, displacing the original wall materials (shown in Figure 6).

Aside from localised damage resulting from tree root growth the wall appears to be in a generally fair condition with minor concrete cracking and no visible displacement or distortion of the wall identified.

Figure 6 - Examples of root growth through the lake wall

- It is not proposed to include within the project scope any remedial works to the existing wall. Instead, we recommend that the wall is left in place (with lowering to accommodate the boardwalk where applicable) and subject to a scheduled monitoring programme (say as a minimum visual inspection every 3-5 years by a structural engineer) to identify potential changes in the condition and/or movement of the wall and necessary future maintenance/replacement over time (this is not unique to the West Basin and applies to many other stretches of wall around the lake originally built about the same time).

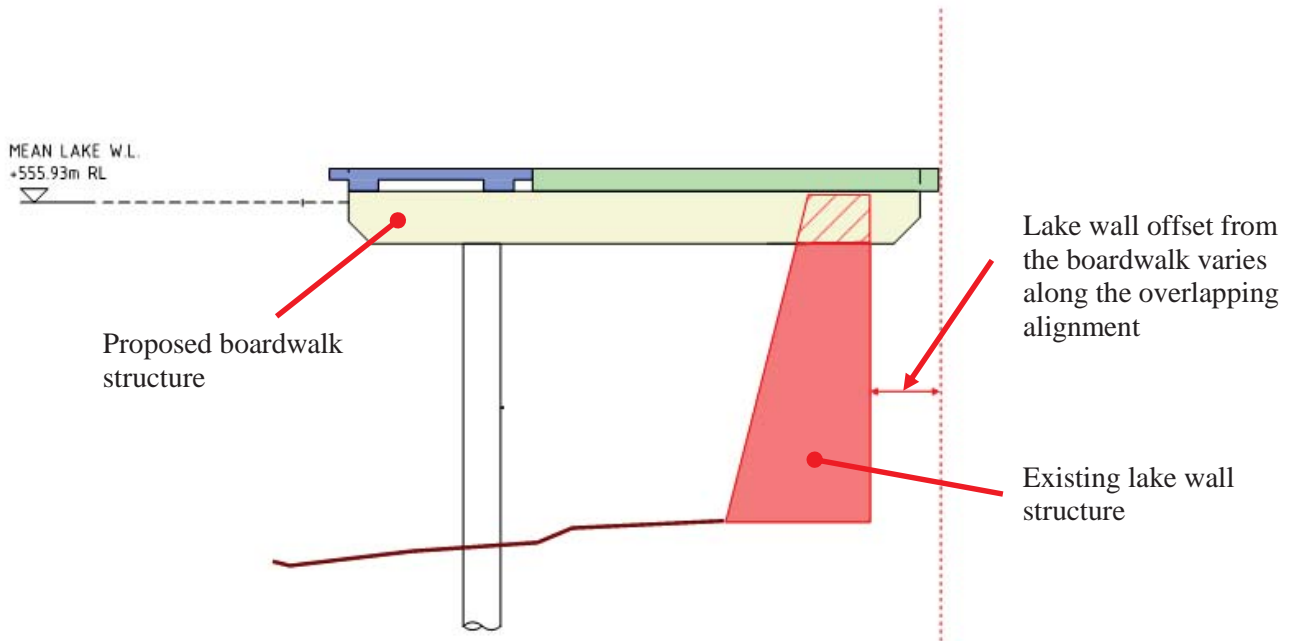
Figure 7 - Boardwalk support over the lake wall structure

The existing lake wall structure may not be suitable to provide structural support to the boardwalk. This is due to both uncertainty around the wall's remaining service life, as discussed in Section 4.1, and the unknown residual structural capacity to resist additional loads from the boardwalk.

- For the Concept Design, it will be assumed that the existing lake wall is not suitable to use as support for the new boardwalk structure. Should the D&C contractor wish to incorporate the wall into their detailed design as structural support to the boardwalk they should be required to undertake further investigation and analysis to the existing lake wall structures – ***to be included as a requirement in the Technical Documentation;***

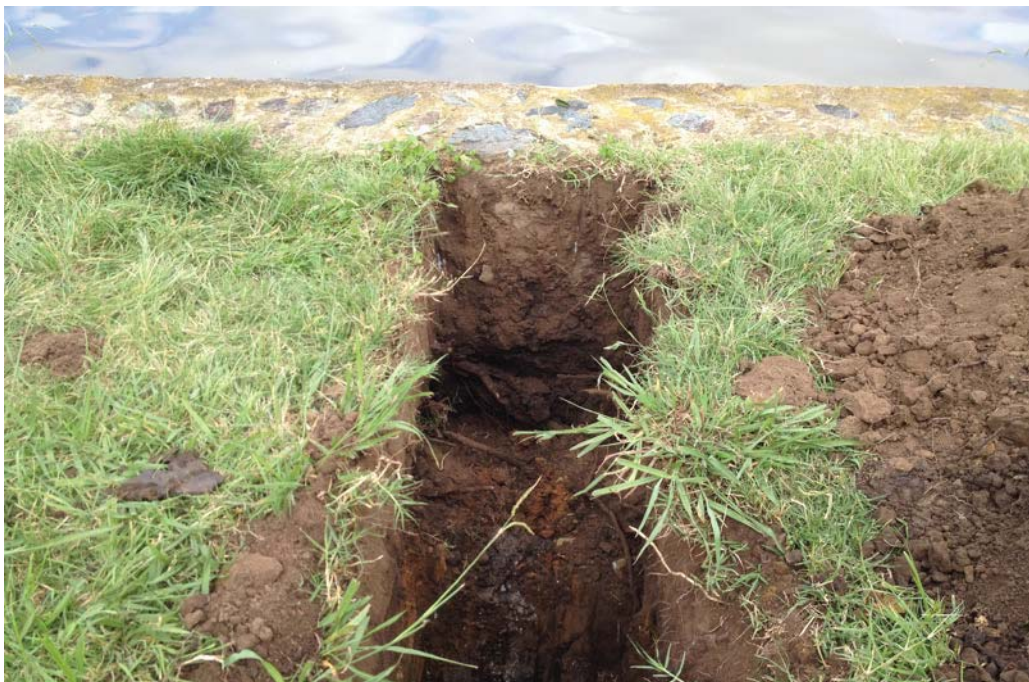
Photo 2 – View of front of Test Pit 1 adjacent to the lake wall

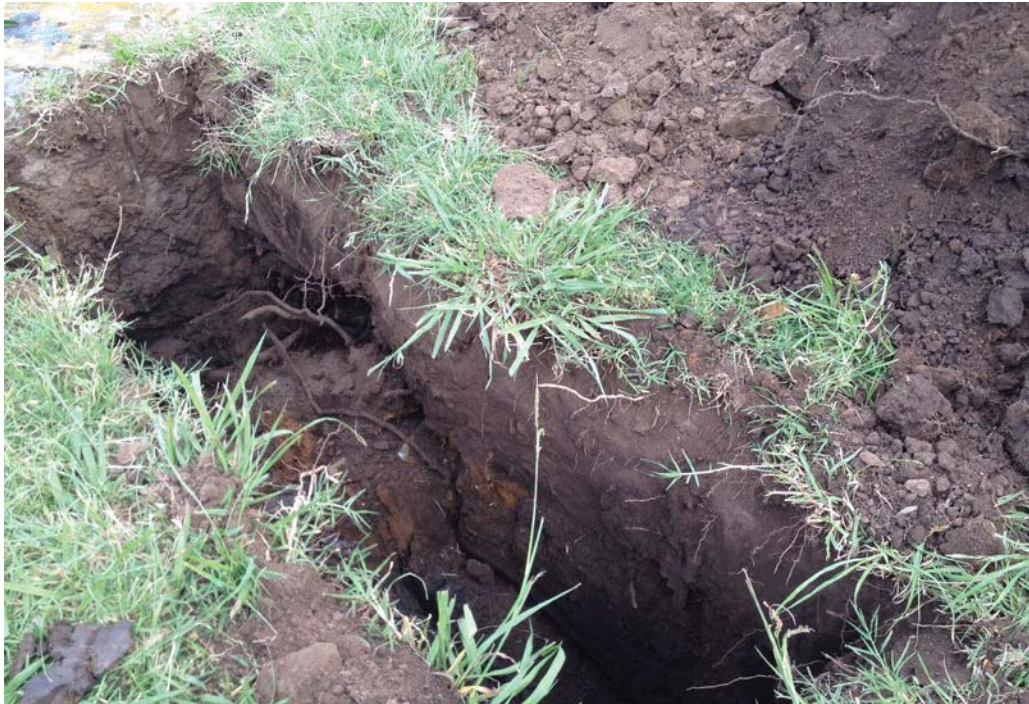
Photo 3 – View of northern pit wall of Pit 1

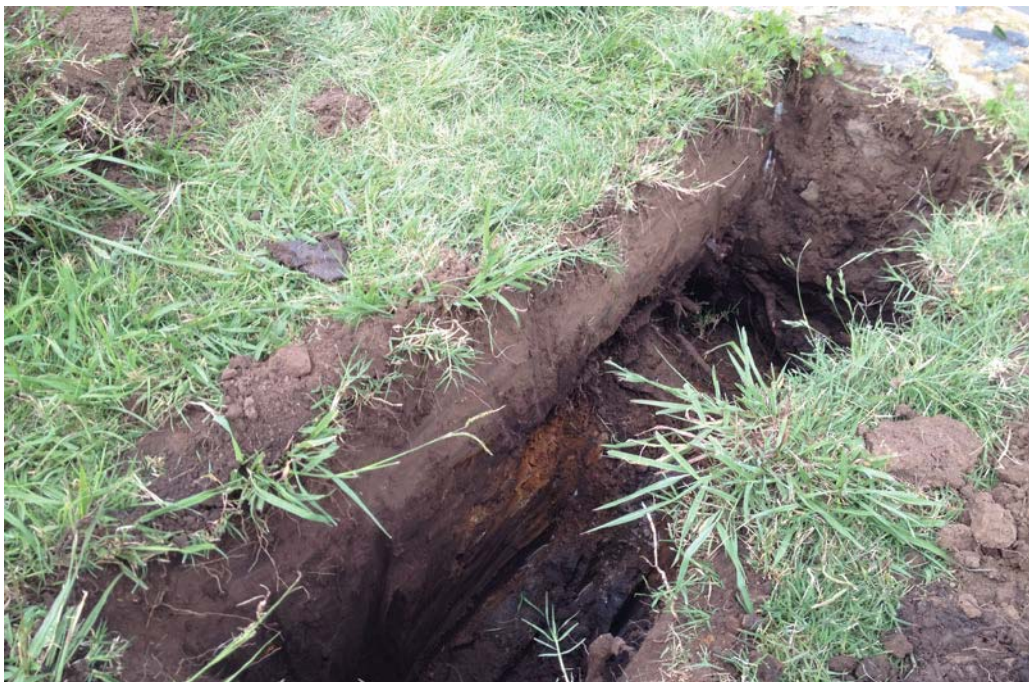
Photo 4 – View of southern pit wall of Pit 1

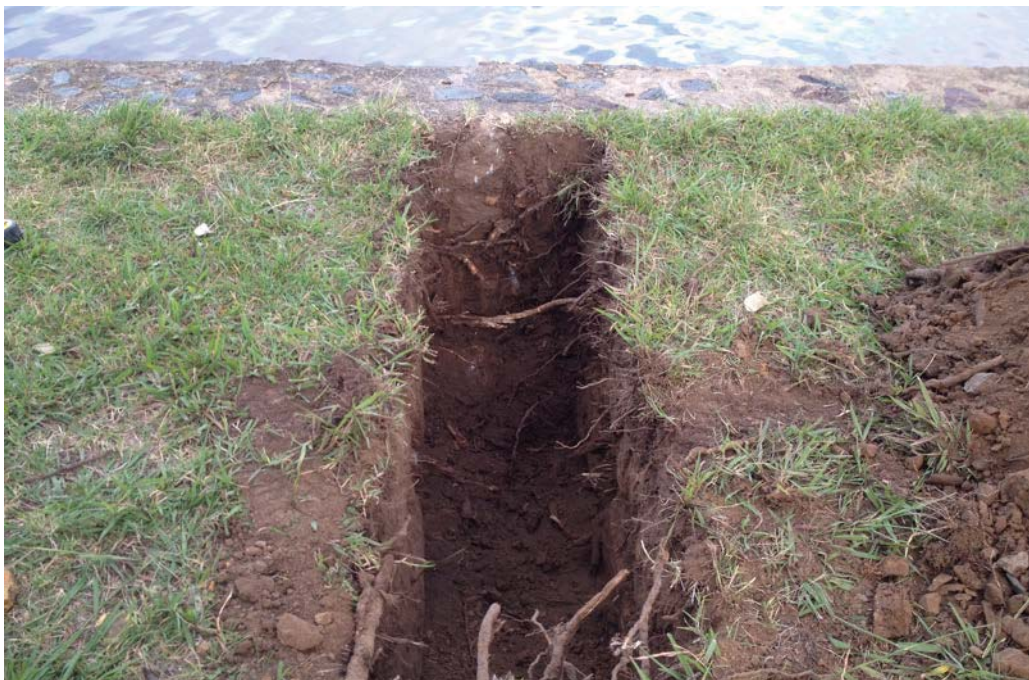
Photo 6 – View of front of Test Pit 2 adjacent to the lake wall

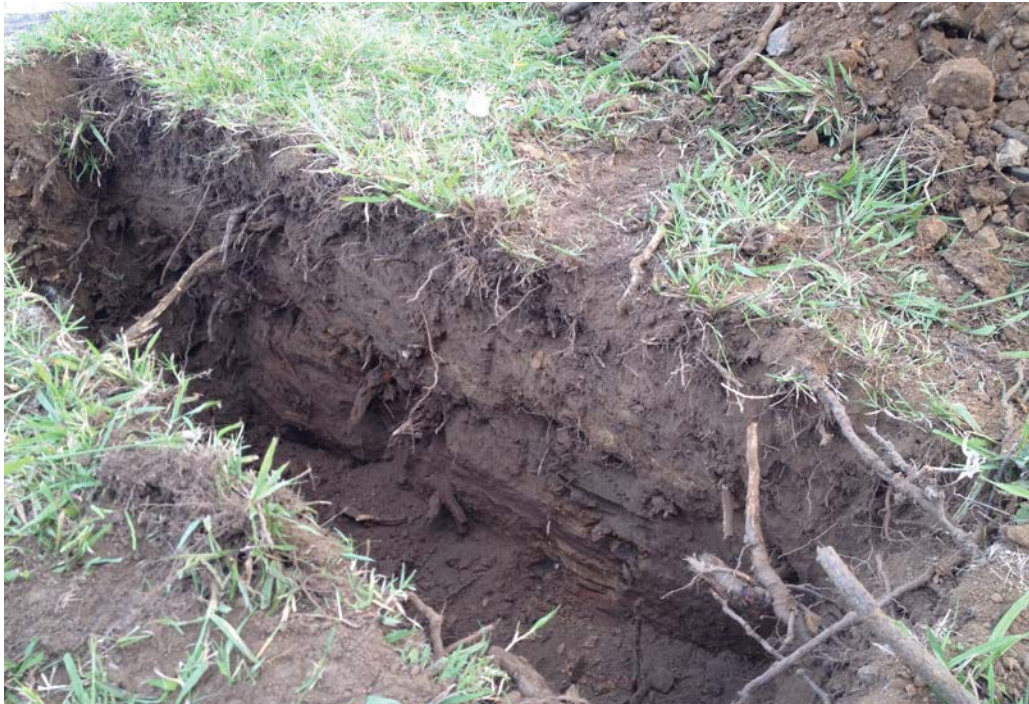
Photo 7 – View of northern pit wall of Pit 2

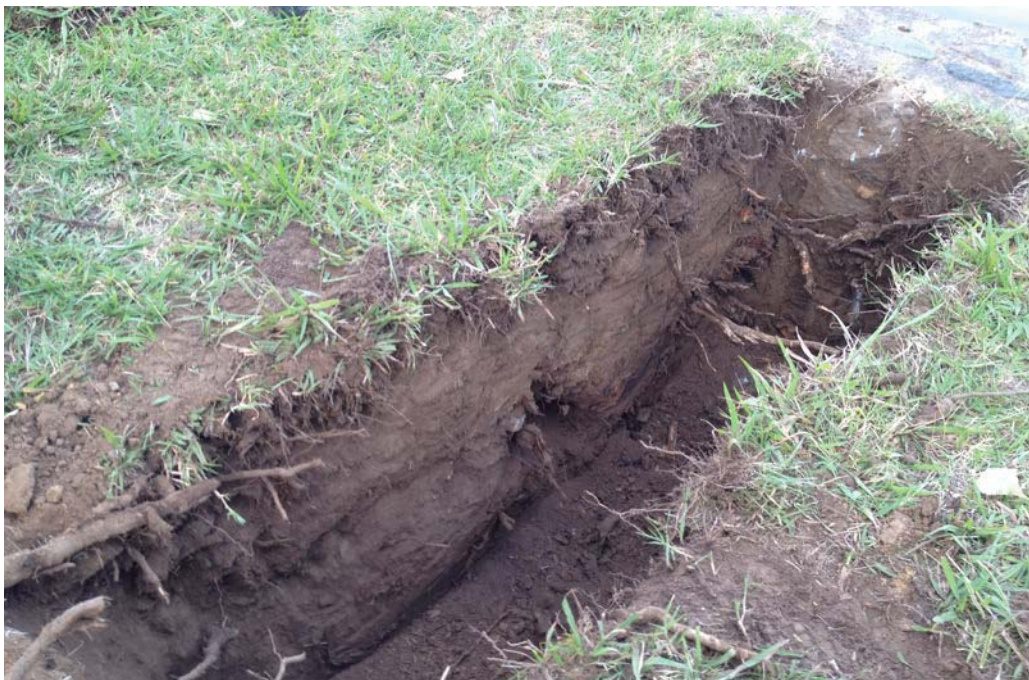
Photo 8 – View of southern pit wall of Pit 2
