**BLOCKS 15 + 16 SECTION 17 YARRALUMLA BAY
CGGS AQUATIC FACILITY**

This Planning Report has been prepared by Stewart Architecture (SA) on behalf of the Canberra Girls Gramma School (CGGS), for the development of Blocks 15 + 16 Section 17 Yarralumla Bay.

This report is intended to support a Works Approval application for the CGGS Aquatic Facility (MWSF) Blocks 15 + 16 Section 17, Yarralumla Bay.

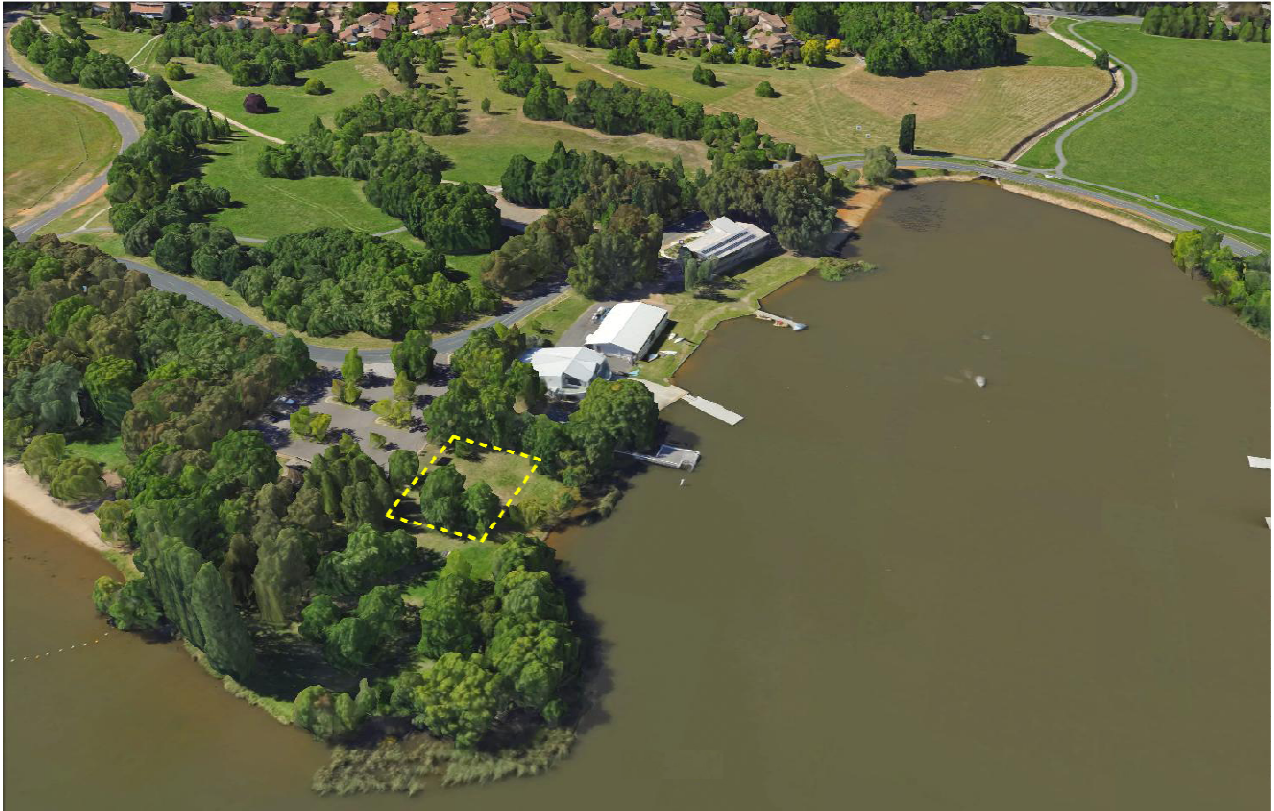
The proposal includes amalgamating Blocks 15 + 16 Section 17. The site has a combined area of 1363sqm.

The site is currently undeveloped and has a cross-fall of approximately 3m from the eastern to western boundary. Following the capture of the above image, site servicing works have been undertaken. The work included the removal of several trees, removal of a picnic table and hard treatment to the lake's edge. All of this work was carried out by the LDA under an NCA Works Approval prior to the sale of the site.

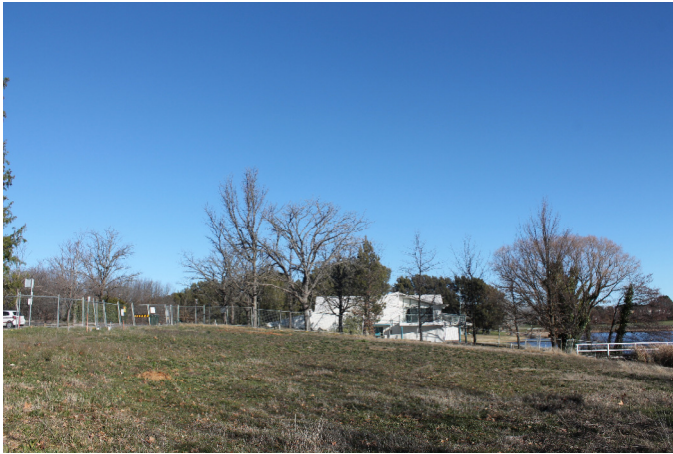
View of site looking south.

The Elizabeth McKay Aquatic Centre - the current CGGS aquatic facility - in the background. Note the significant fall over the site providing a westerly aspect over Yarralumla Bay. The site was serviced by the LDA in 2013, including the construction of a pedestrian pathway and rubber buffer to the lake's edge.

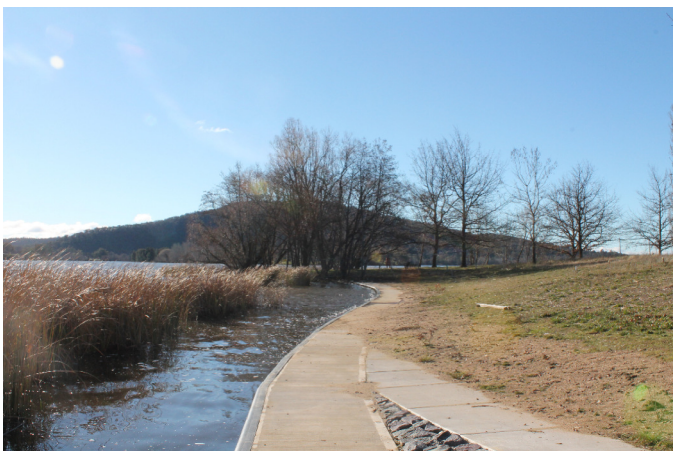
View of the lake's edge looking north.

Existing works at lake's edge include a 1.2m pathway, and rubber buffer to the edge. Existing reeds stand approx. 2m and provide considerable screening to the site from Yarralumla Bay.

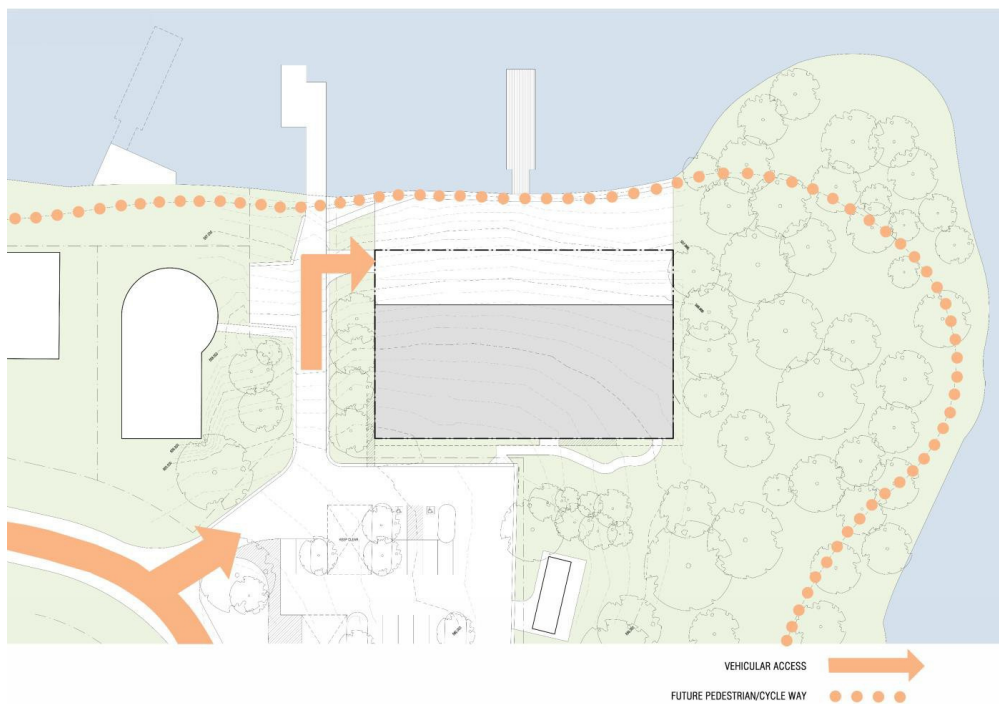
Although currently inaccessible by any designated pedestrian route, the Yarralumla Bay Recreation Hub Master Plan identifies a nodal extension of the primary pedestrian/cycle way that activates the Yarralumla Bay Peninsula (east) and passes directly between the site and the lake's edge.

Pedestrian access is limited to the primary pedestrian/cycle path offset to the east of Alexandrina Drive (refer DA 000). The Yarralumla Bay Recreation Hub Master Plan identifies a nodal extension of this path however that activates the eastern Yarralumla Bay Peninsula and passes across the lake's edge directly in front of the site. This proposal presents a catalyst for this extension by proposing a café and outdoor terrace opening to the north, developing the lake edge in preparation of this path extension and fulfilling all activation, characteristic and land use objectives outlined in the Yarralumla Bay Master Plan.

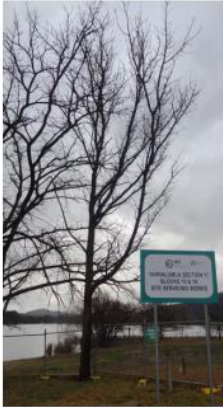
Tree # 1	Tree # 2	Tree # 3	Tree # 4

Tree #	Common Tree name	Observation comments
1	English oak	In good condition, evidence of dead branches and stubs
2	English oak	In good condition, evidence of dead branches
3	English oak	Healthy tree
4	English oak	Healthy tree, minor dead branches noticed, mechanical damage at base of trunk in the form of possible mower damage
5	English oak	Excellent tree
6	English oak	Good condition, evidence of <i>Phellinus sp.</i> activity. Recommend monitoring in 12 months.
7	English oak	Healthy and sound
8	Black alder	Fair condition, bifurcated (co-dominant stem) with a bark included fork, possibly weaken the structure.
9	London plane	Healthy tree
10	English oak	Excellent tree
11	English oak	Excellent tree
12	English oak	Good condition, minor dead branches present
13	English oak	Good condition, minor dead branches present
14	She-oak	Good condition, minor bark included fork
15	Arizona cypress	Fair condition tree is in need of more light on foliage

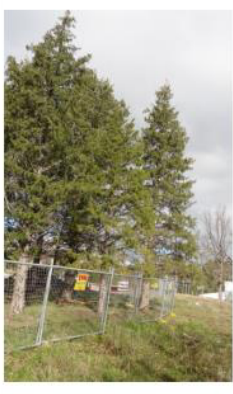
Tree # 13	Tree # 14	Tree # 15 and Tree # 16	Tree # 17

16	Arizona cypress	Fair condition tree is in need of more light on foliage, poor pruning noted, minor deadwood evident
17	Arizona cypress	Fair condition tree is in need of more light on dead foliage branches greater than 25mm in diameter
18	Arizona cypress	Fair condition tree is in need of more light on foliage; tree has weakened compression unions.
19	English oak	Good condition
20	Arizona cypress	Minor bark included fork, tree is stressed due to lack of light but ok
21	Arizona cypress	Good condition
22	Arizona cypress	The tree has compression unions recommend monitoring this tree in 12 months.

Having observed where the Contiguous Bore Piles are to take place, there are some trees that will not suit this encroachment, that is greater than 10% of trees root zone removed. Tree Numbered 1,2,7,15, and 16 will be mostly effected and should be removed and stumps ground.

We recommend the protection and retainment of trees numbered 3,4,5,6,8,9,10,11,12,13,14,19,20,21 and 22. These trees are recommended to be protected during the phases of various activities on the building site. They require a 1.8m high steel messed fencing. Around their root zones (refer to observation Table on page 6 for various zones needed).Tree protection fencing are to be pegged down, protecting as much of the trees Primary root zone.
