ISSUE:	DATE:	CONSULTANTS:	ARCHITECT:	PROJECT:	NORTH POINT	DRAWING TITLE:	DRAWING NO.
A	21.01.20		<b>T+AA</b> Townsend + Associates Architects E info@t-a.com.au P (02) 6257 7033	<b>REGATTA POINT ALTERATIONS + ADDITIONS</b>		<b>TREE PROTECTION INFORMATION</b>	<b>LS02</b>
ISSUED FOR WORKS APPROVAL			SCALE BAR: 0 2 4 6 8 10 15 25 METRES	CLIENT: 		STAGE: <b>WORKS APPROVAL</b>	
						DRAWN: AE	ISSUE: A
						CHECKED: -	
						VERIFIED: -	
						DATE: JAN 2020	
						SCALE: 1:500 @ A3 1:250 @ A1	
						JOB NO. 1903

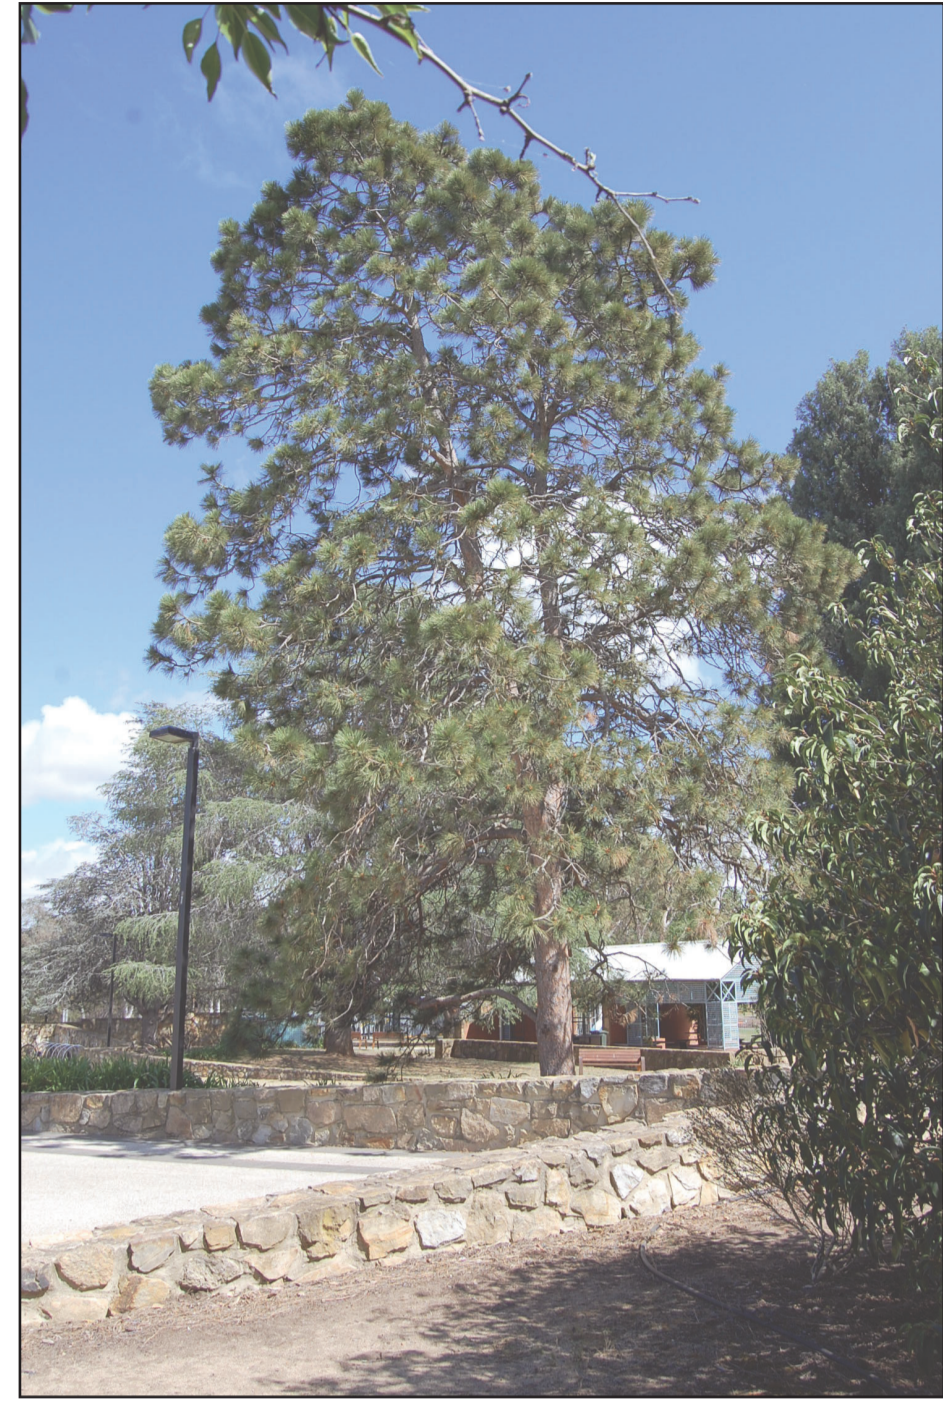
**TREE 01 (TO BE REMOVED)**

PT NO. 23  
NCA NO. 3427  
PINUS CANARIENSIS

Currently in good condition. Sits adjacent to Western Pinus plantings, yet due to different species, canopy characteristics and general appearance TREE 01 is clearly no part of these plantings. TREE 01 will be compromised due to proposed levels to create open grass area and demolition of current underground toilets which is part of brief.

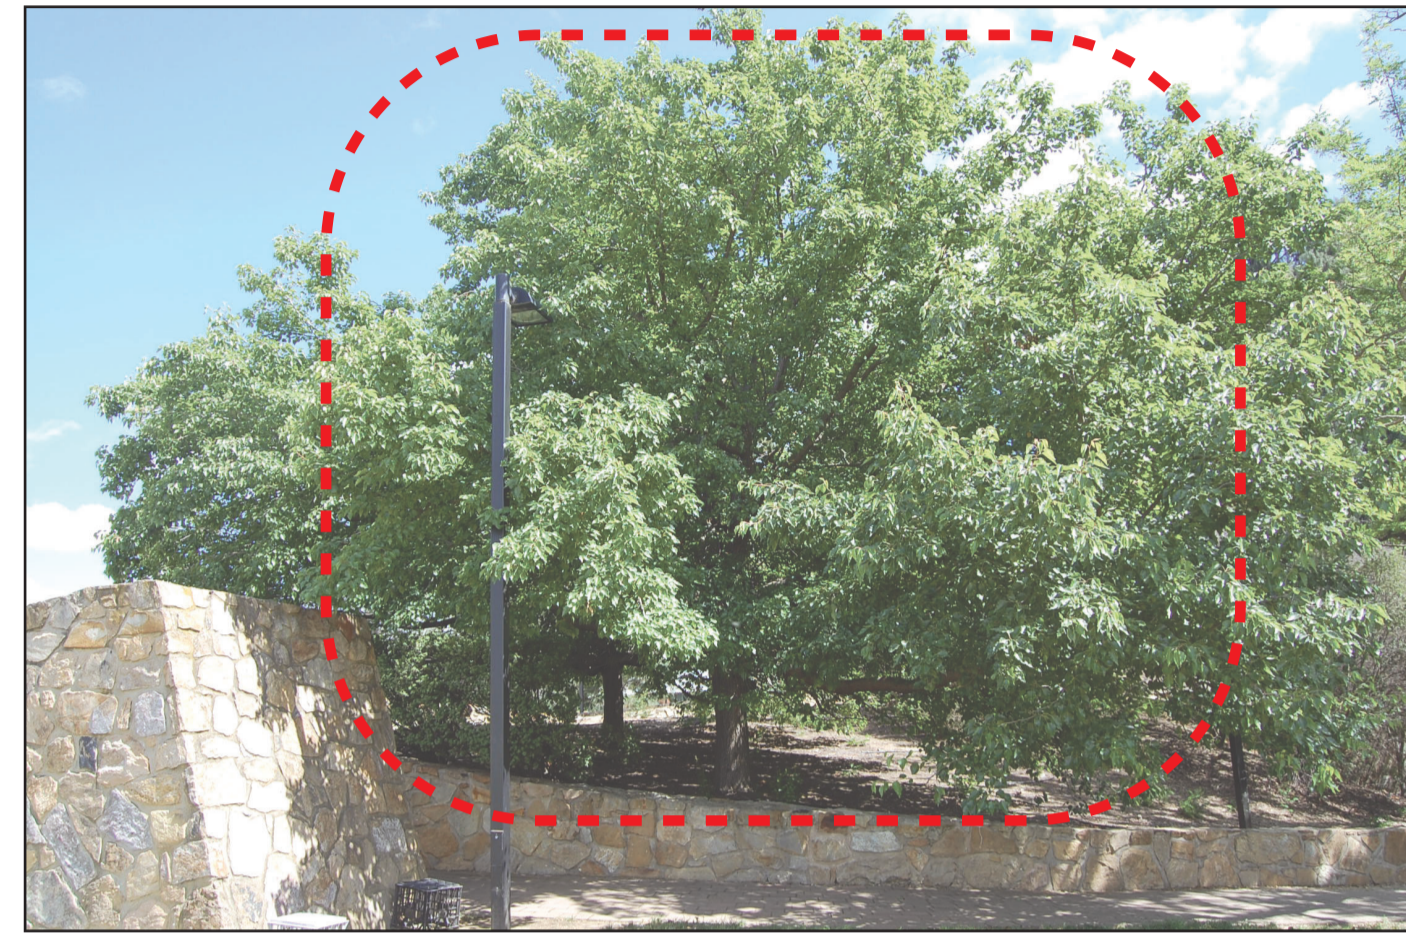
**TREE 02 (TO BE REMOVED)**

PT NO. 30  
NCA NO. N/A  
PYRUS USSURIENSIS

Deciduous tree, seemingly in good condition. TREE 02 sits in raised landscape behind retaining wall due to location of underground toilets. Will be compromised due to demolition of toilets and creation of new grass landscape. Required to be demolished to enable construction of proposed accessible walkway.

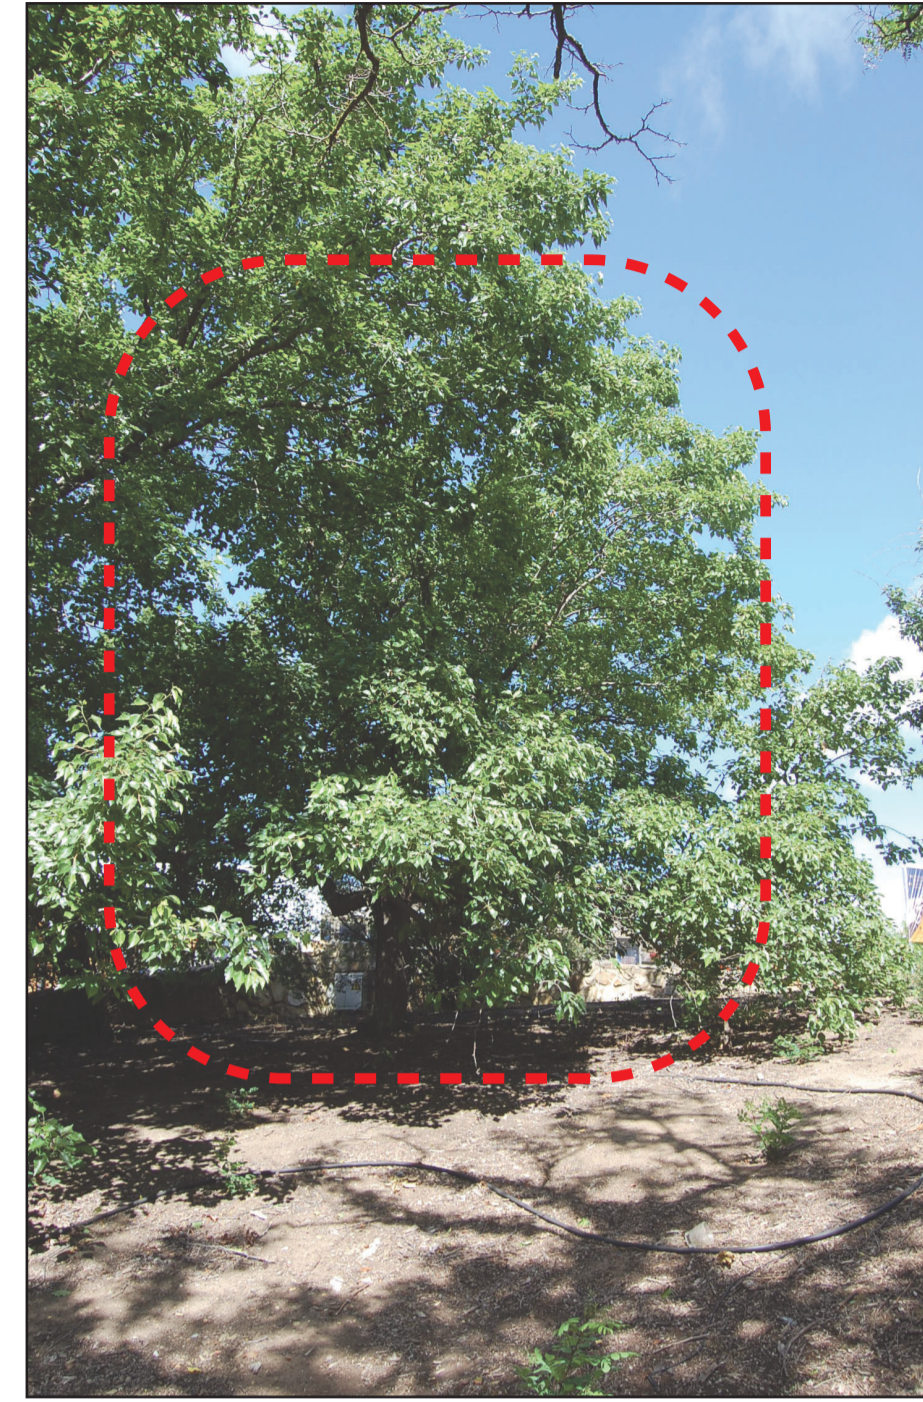
**TREE 03 (TO BE REMOVED)**

PT NO. 30  
NCA NO. N/A  
PYRUS USSURIENSIS

Deciduous tree, seemingly in good condition. TREE 03 sits in raised landscape behind retaining wall due to location of underground toilets. Will be compromised due to demolition of toilets and creation of new grass landscape. Required to be demolished to enable construction of proposed accessible walkway.

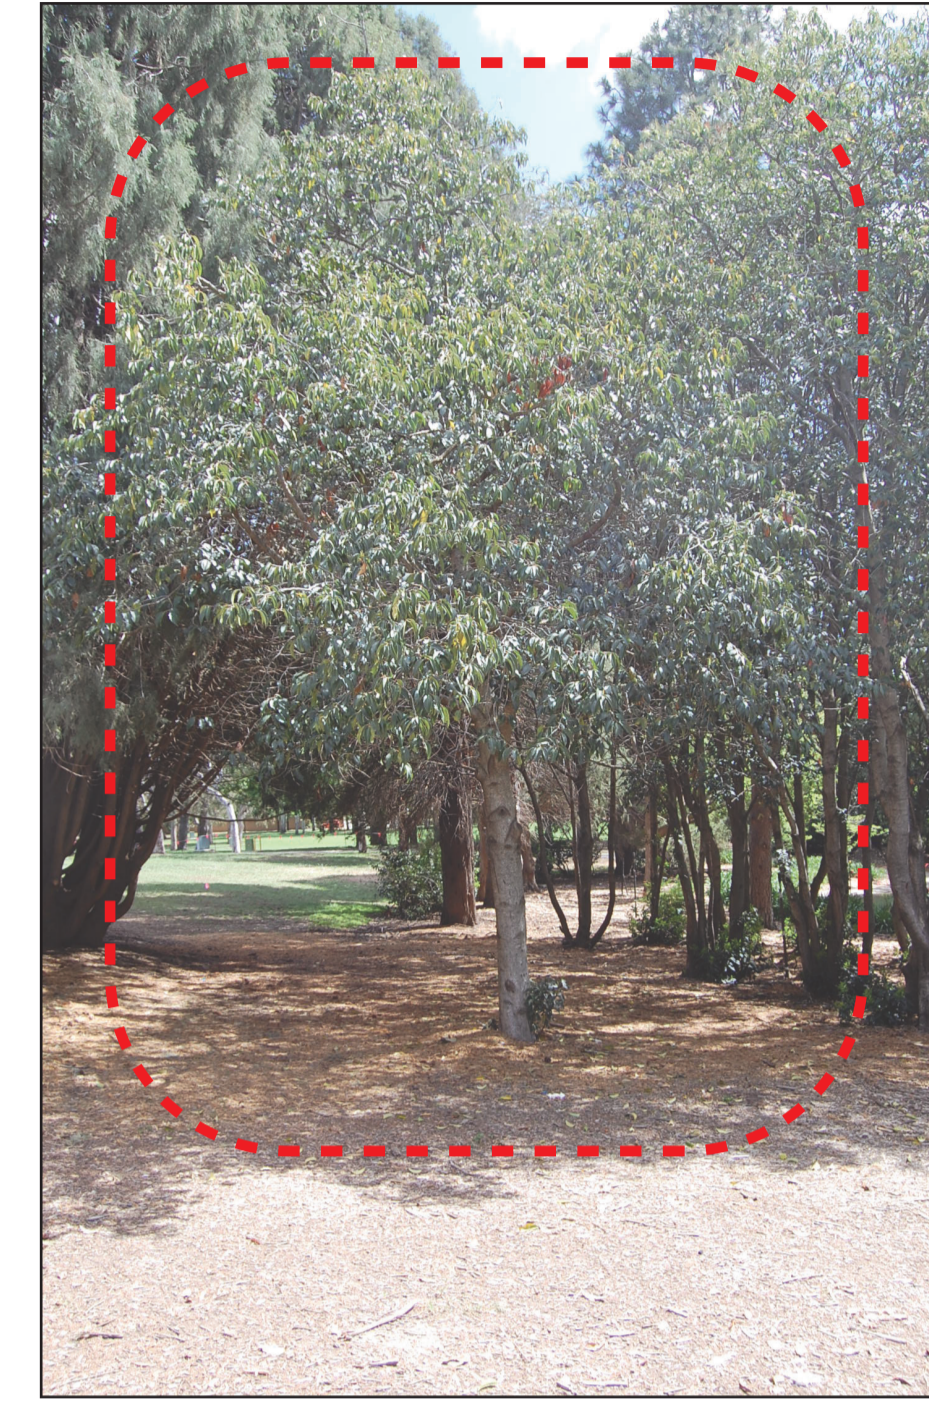
**TREE 04 (TO BE REMOVED)**

PT NO. 145  
NCA NO. 1842  
PRUNUS LUSITANICA

TREE 04 seemingly in decent condition. Removal required for construction of proposed service road/pedestrian walkway.

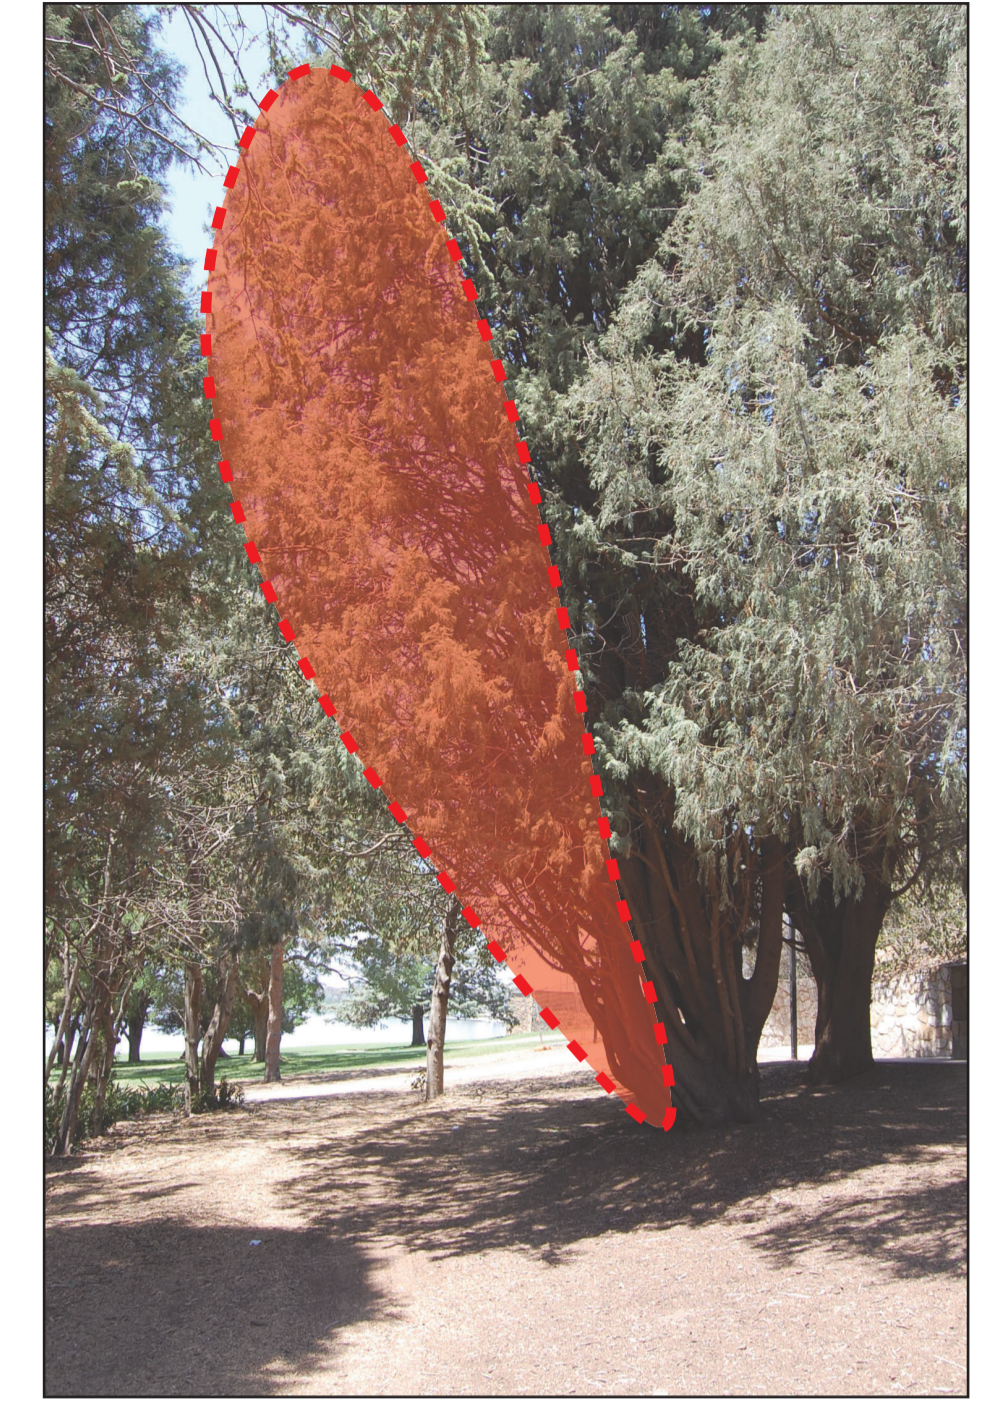
**TREE 05 (TO BE TRIMMED)**

Pt No. 152  
NCA No. N/A  
CUPRESSUS SEMPERVIRENS

TREE 05 seemingly in decent condition. Trimming of tree required for protection and to allow access for heavier vehicle, eg. Garbage trucks. Branches to be trimmed to allow for 6m high clearance as required.

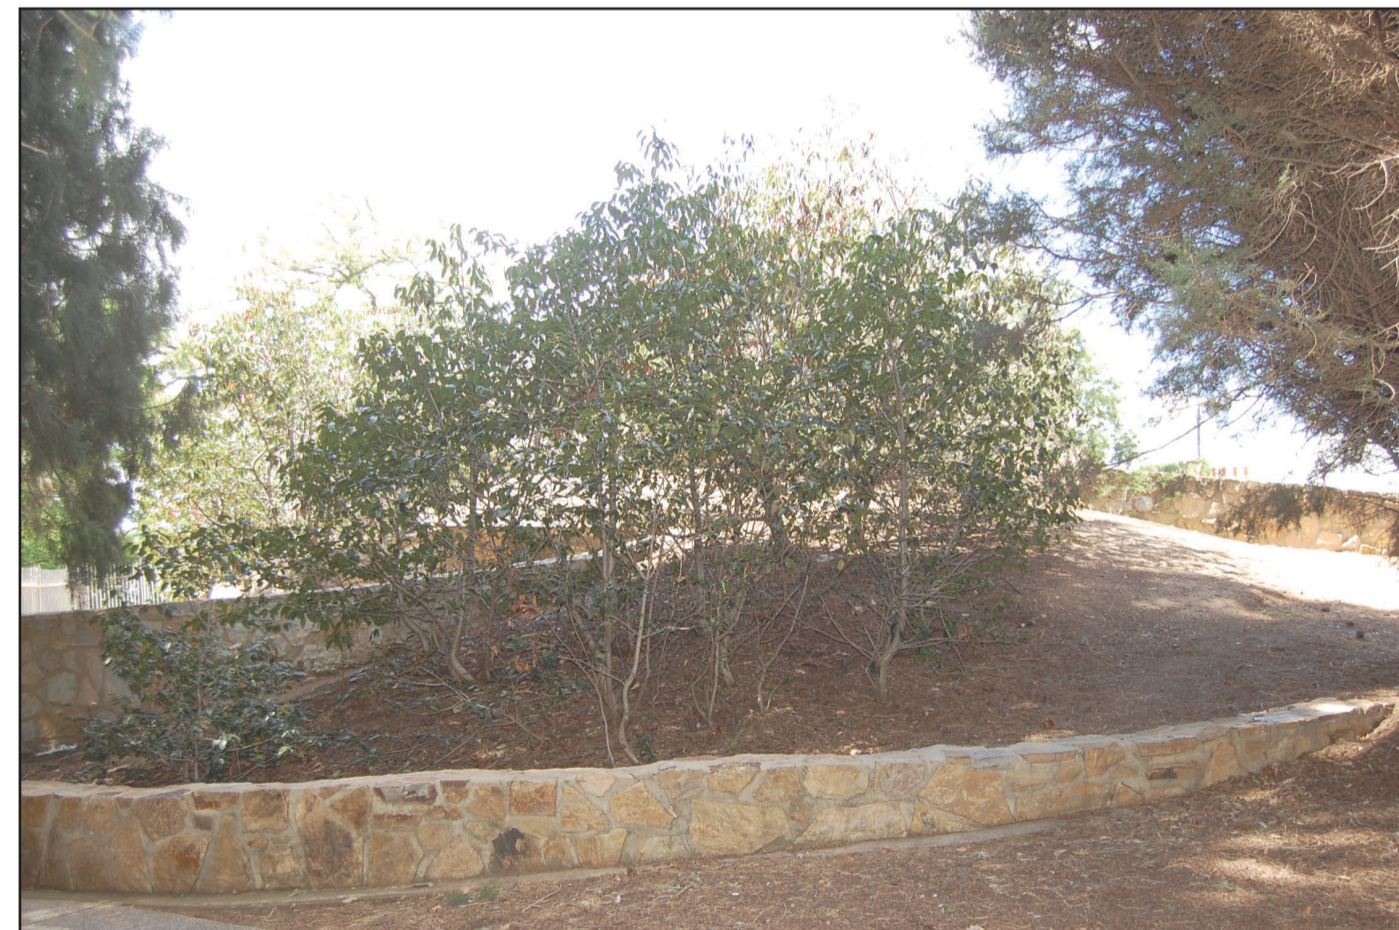
**SHRUBS 06 (TO BE REMOVED)**

PT NO. N/A  
NCA NO. N/A  
PRUNUS LUSITANICA

SHRUBS 06 all seem to be inconsequential shrubbery of varying states of health from okay to dead. Seemingly random and no formalisation to planting. Demolition of underground toilet requires removal of listed shrubs.

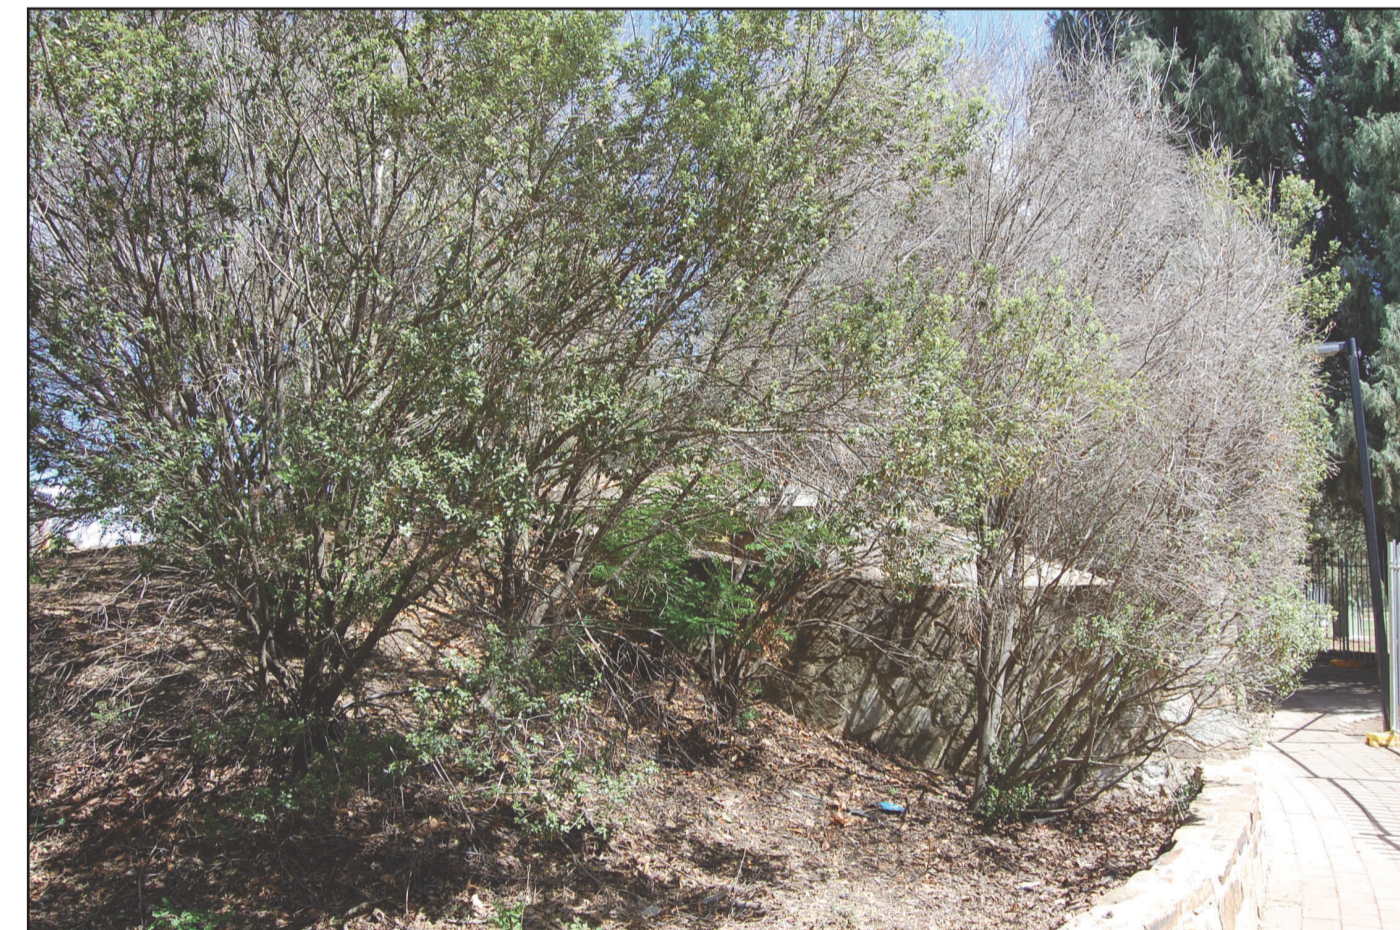
**SHRUBS 07 (TO BE REMOVED)**

PT NO. N/A  
NCA NO. N/A  
ACACIA FIMBRIATA (APPEARS SICK)

SHRUBS 07 all seem to be inconsequential shrubbery of varying states of health from okay to dead. Seemingly random and no formalisation to planting. Demolition of underground toilet requires removal of listed shrubs.

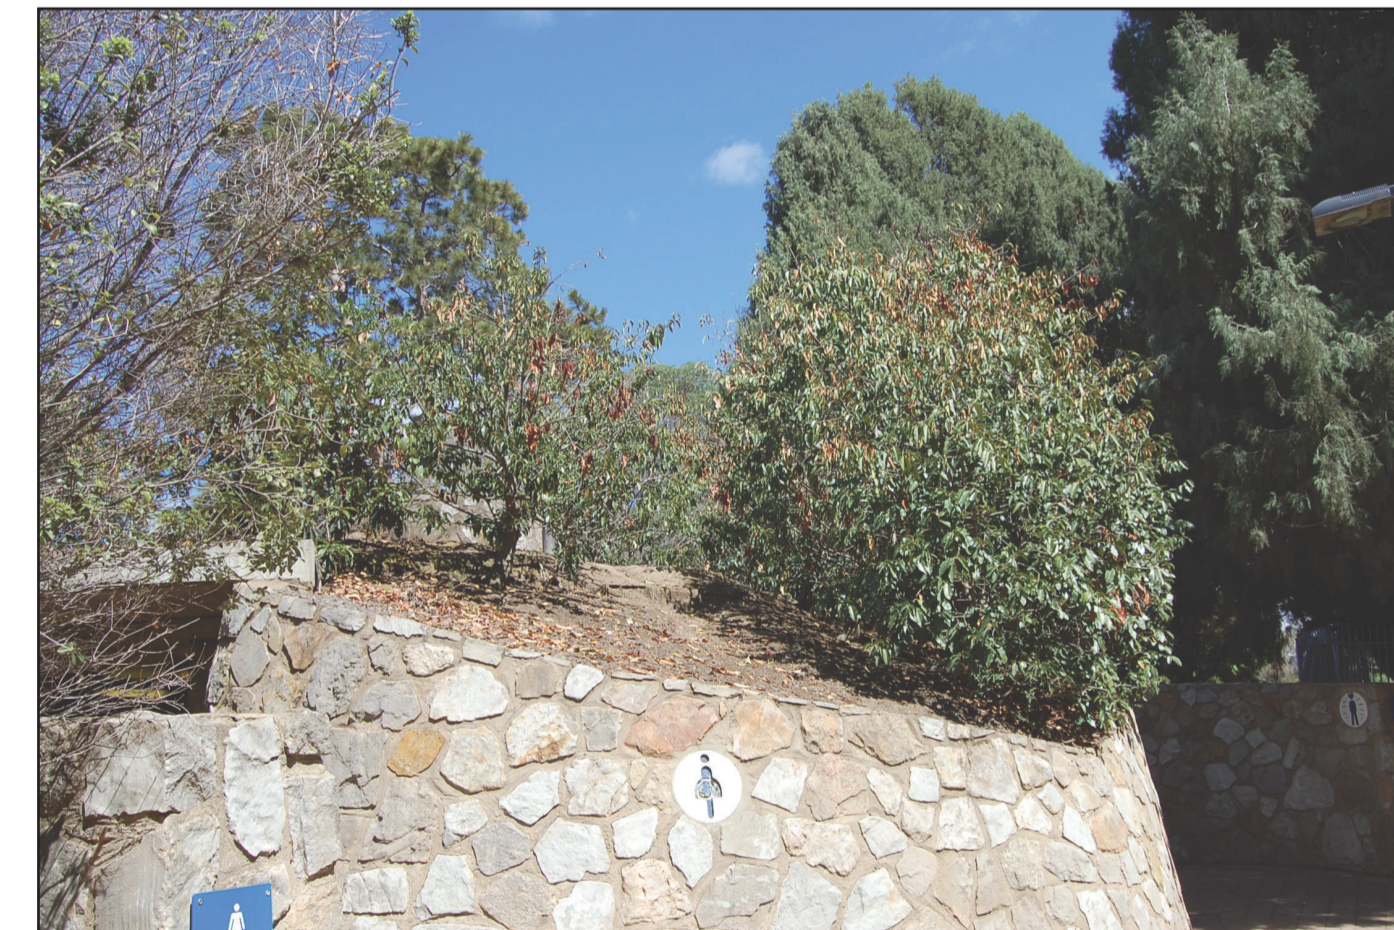
**SHRUBS 08 (TO BE REMOVED)**

PT NO. N/A  
NCA NO. N/A  
PRUNUS LUSITANICA

SHRUBS 08 all seem to be inconsequential shrubbery of varying states of health from okay to dead. Seemingly random and no formalisation to planting. Demolition of underground toilet requires removal of listed shrubs.

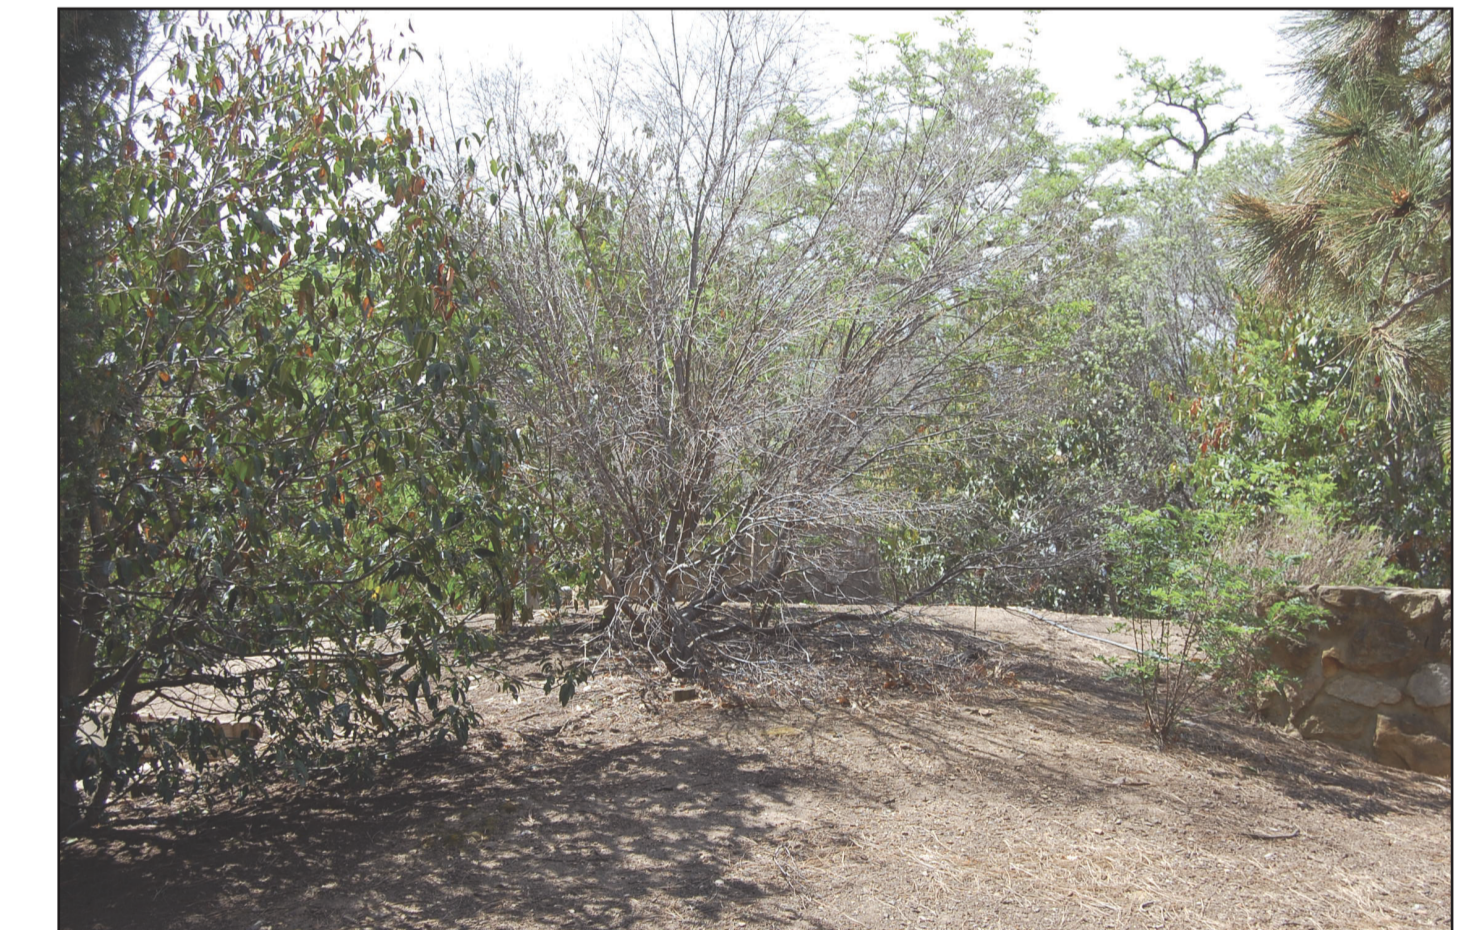
**SHRUBS 09 (TO BE REMOVED)**

PT NO. N/A  
NCA NO. N/A  
ACACIA FIMBRIATA (DEAD)

SHRUBS 09 all seem to be inconsequential shrubbery of varying states of health from okay to dead. Seemingly random and no formalisation to planting. Demolition of underground toilet requires removal of listed shrubs.
